LHC Machine Committee - 22 April, 2009

Sector 3-4 Repair Status

Francesco Bertinelli - TE/MSC
(10 minutes)

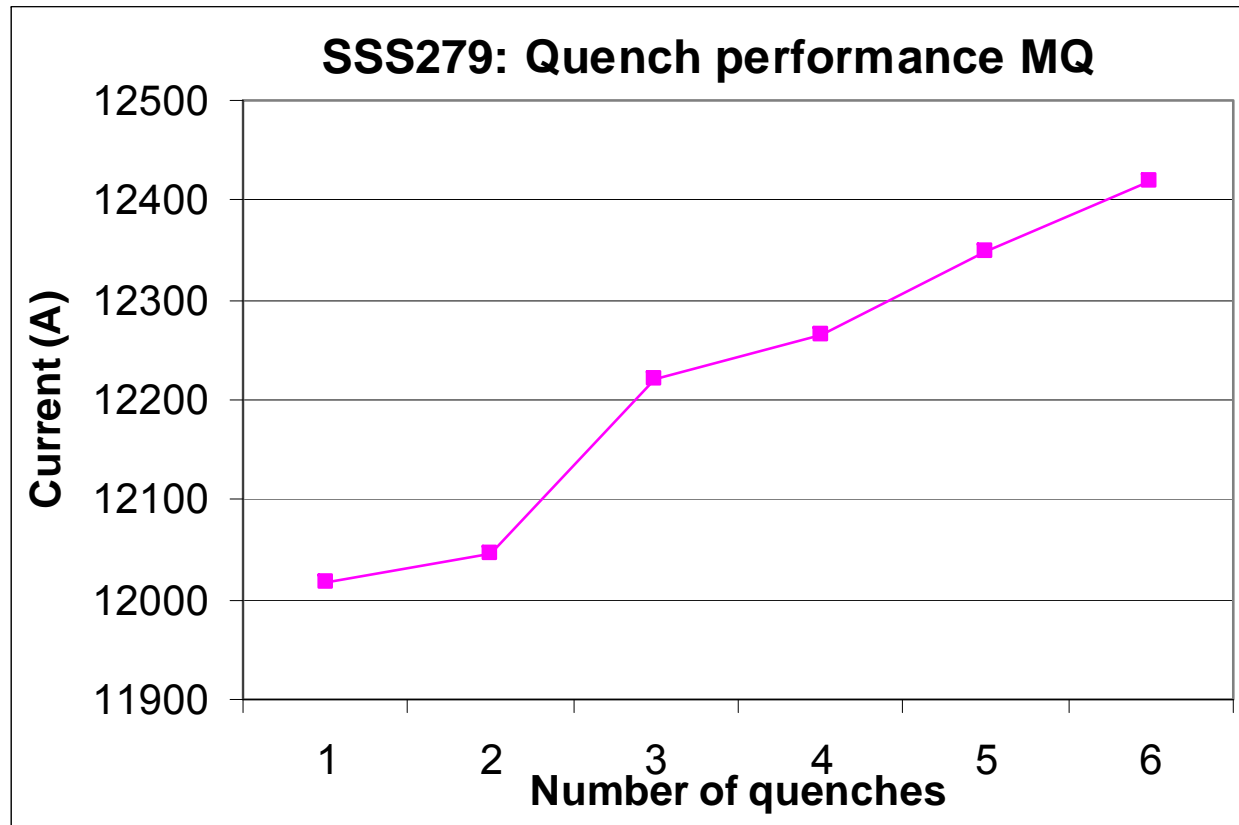
SSS279: MQ quench performance

- then stopped training
- also: correctors OK (problem was on current leads)

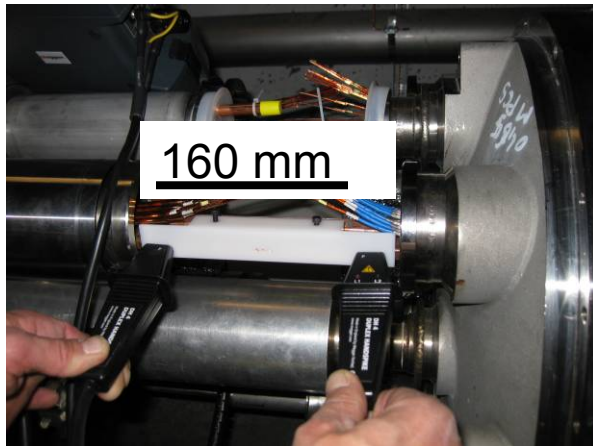
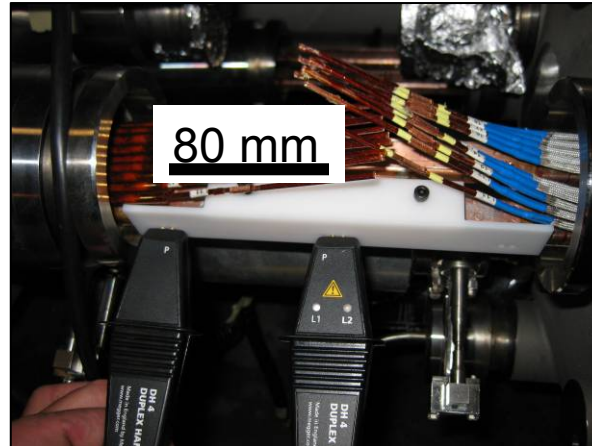
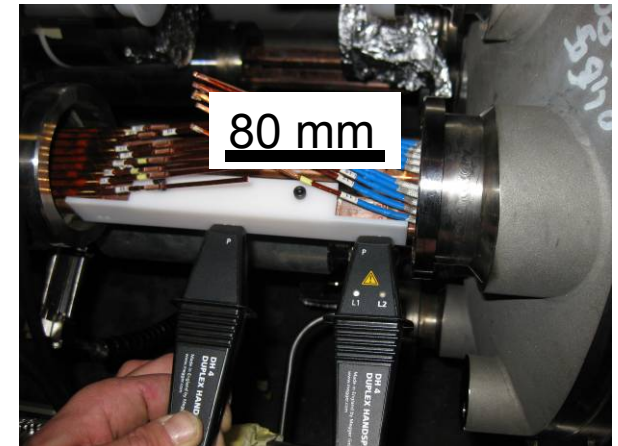
13kA splices Megger measurements

- Room temperature splice resistance measurement done as introduced by TE/MPE.
- Because of the short distance between current source and voltage taps only comparative measurements are possible with the Megger DLR 010.
- Distance between voltage taps 160 mm and 80 mm for total splice and one contact resistance measurement, respectively. Each new result is average value obtained from 3 measurements.
- Dedicated tool has been provided by H. Prin for keeping correct distance between voltage taps.
- Voltage taps always on the side of the splice.

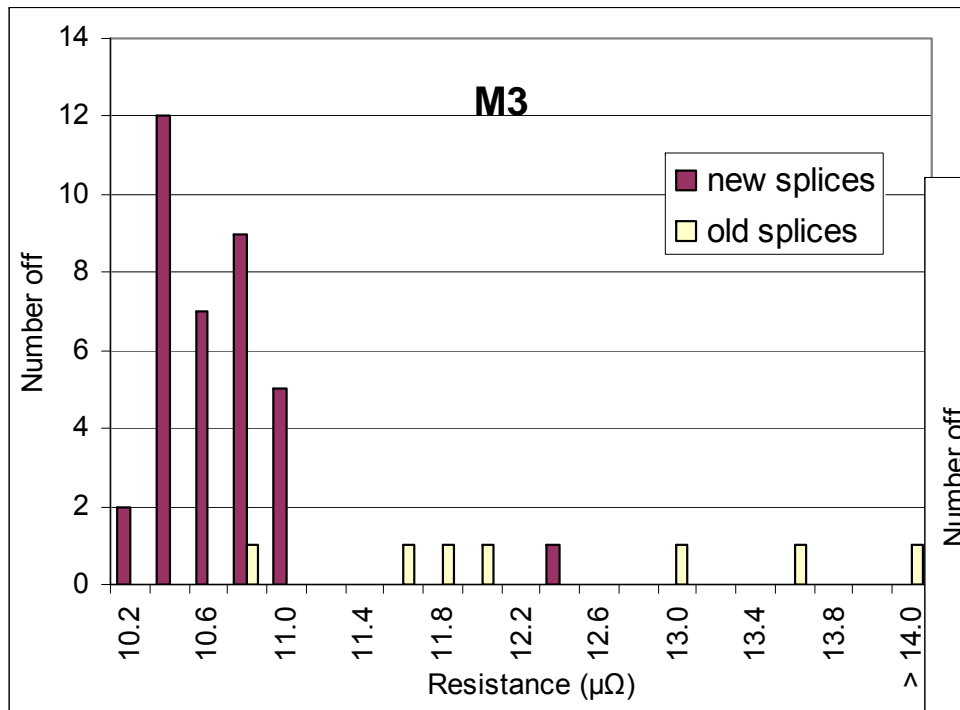
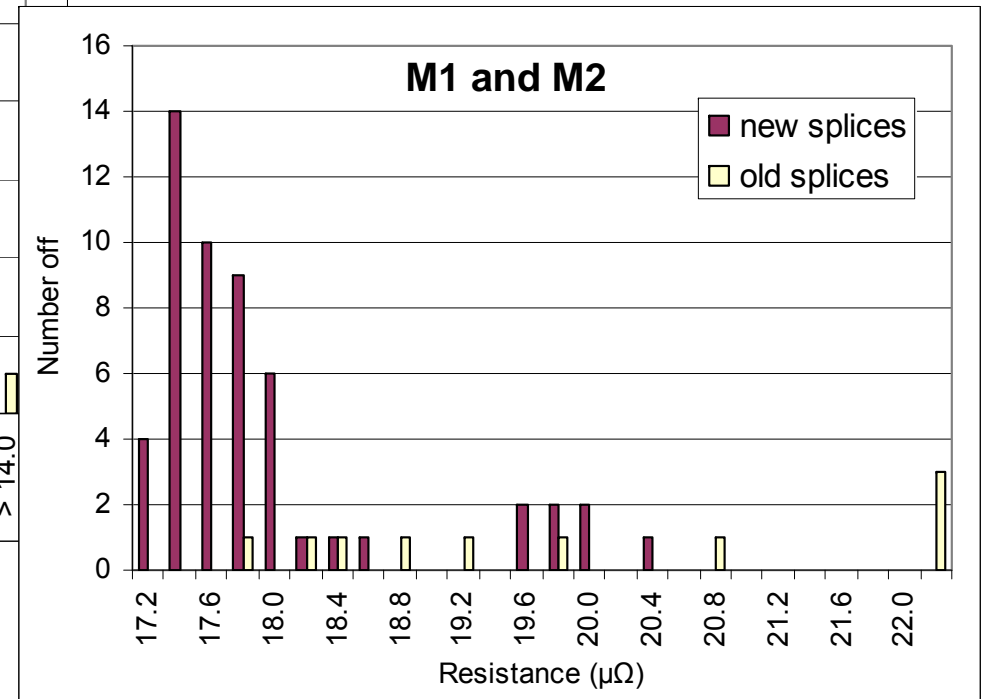
13kA splices Megger results

- Systematic measurements of available splices started W17
- Jig ready
