Insulation fault in sector 67

Documented in NC 1016291

After 3 day of cool-down, a short circuit to ground was detected on the MBA.A67 line of the main dipole circuit. After diagnostic, the defect is localized at the level of dipole 3287 at the position A12R6. The warm-up is launched for repair.

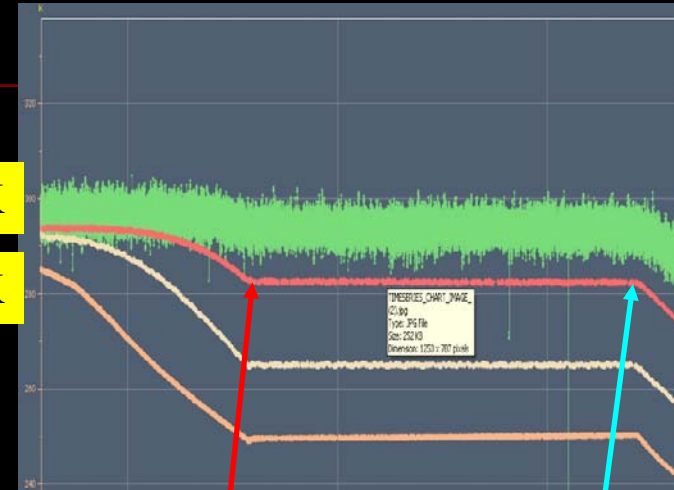
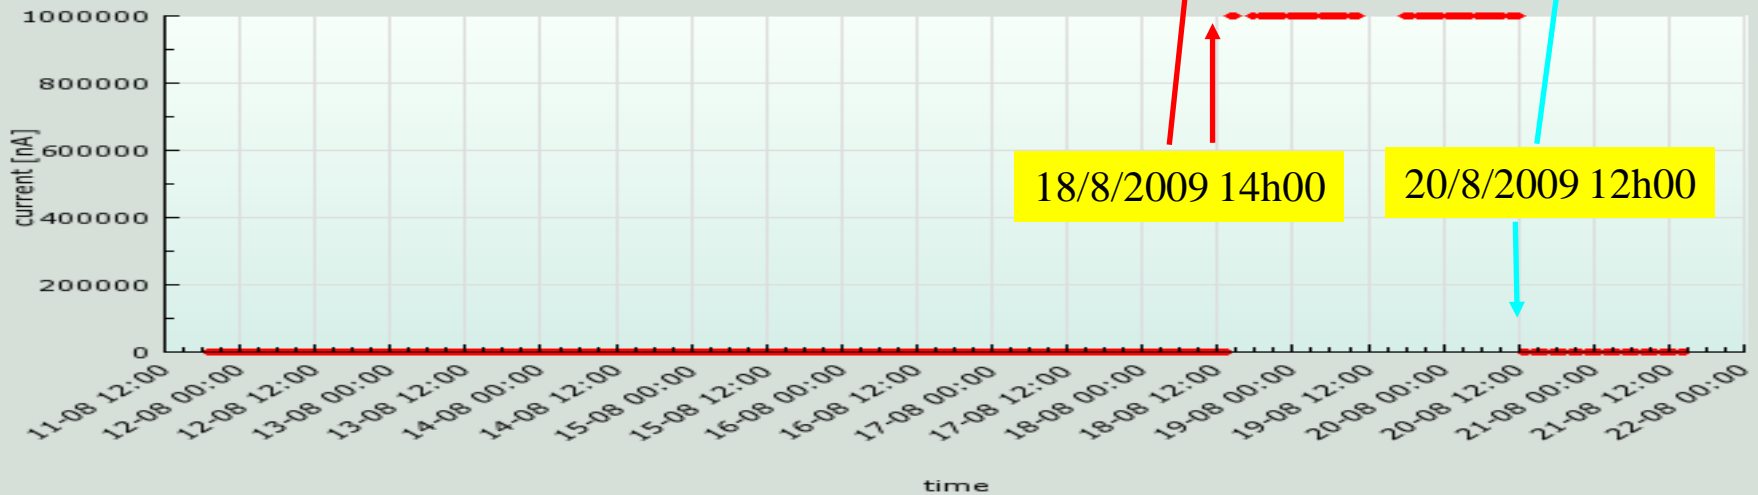
❖ Detection of the short

Detailed information for circuit RB.A67_lead_6

Final leakage current for circuit RB.A67_lead_6

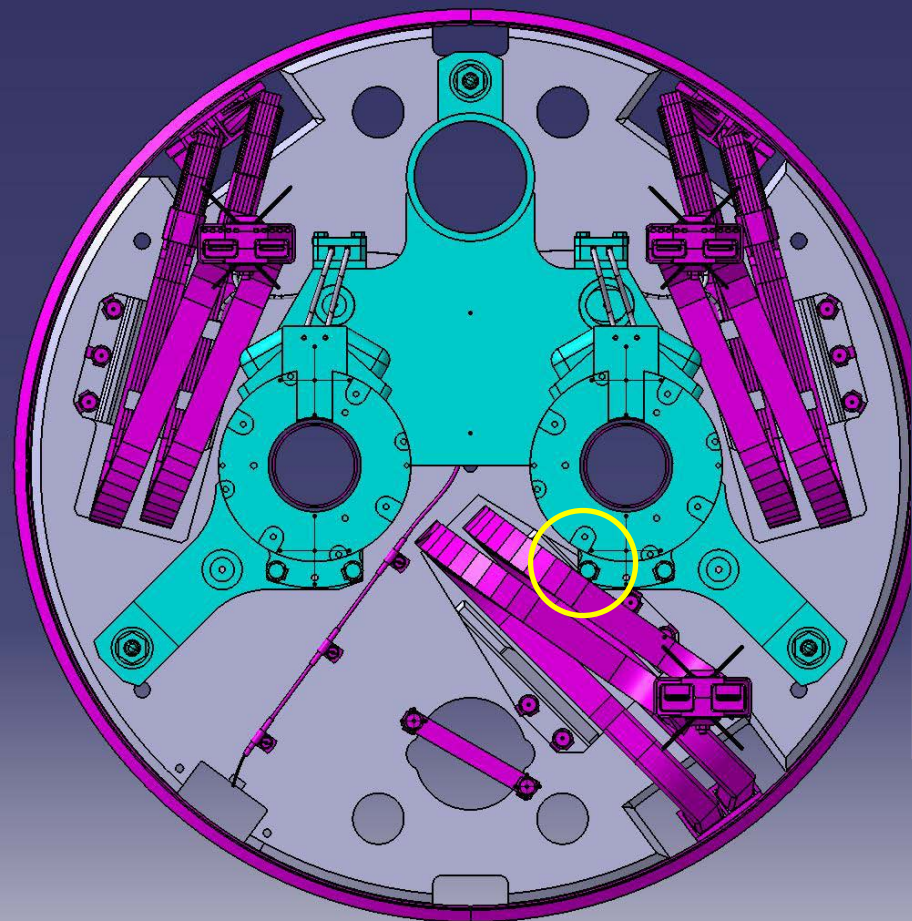
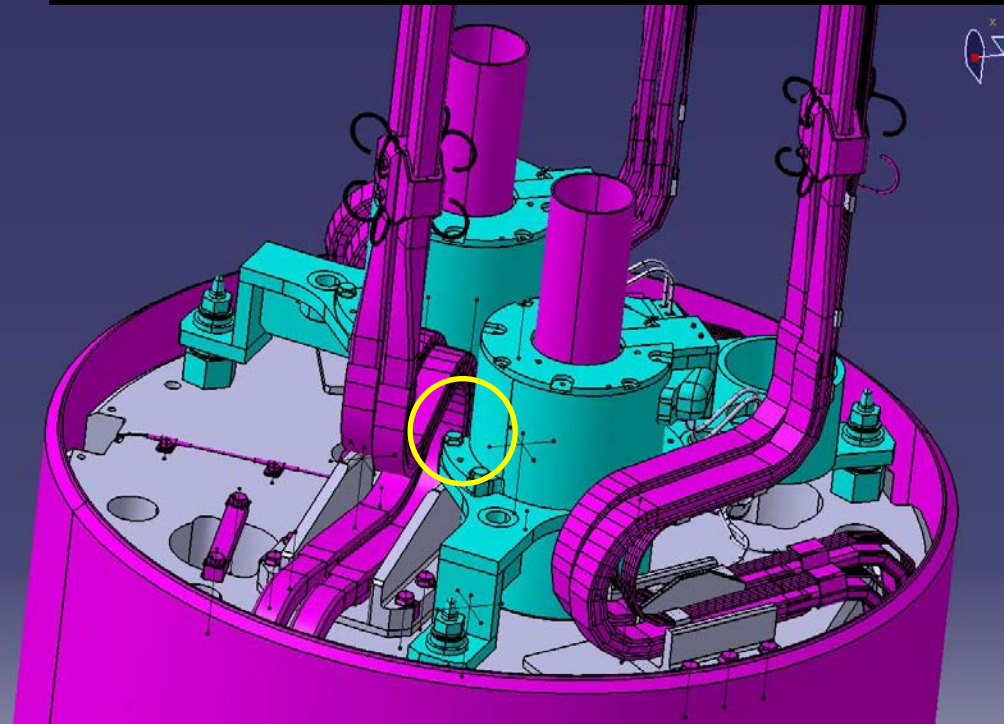
❖ Origin of the short

Beforehand analysis pre-localised the defect

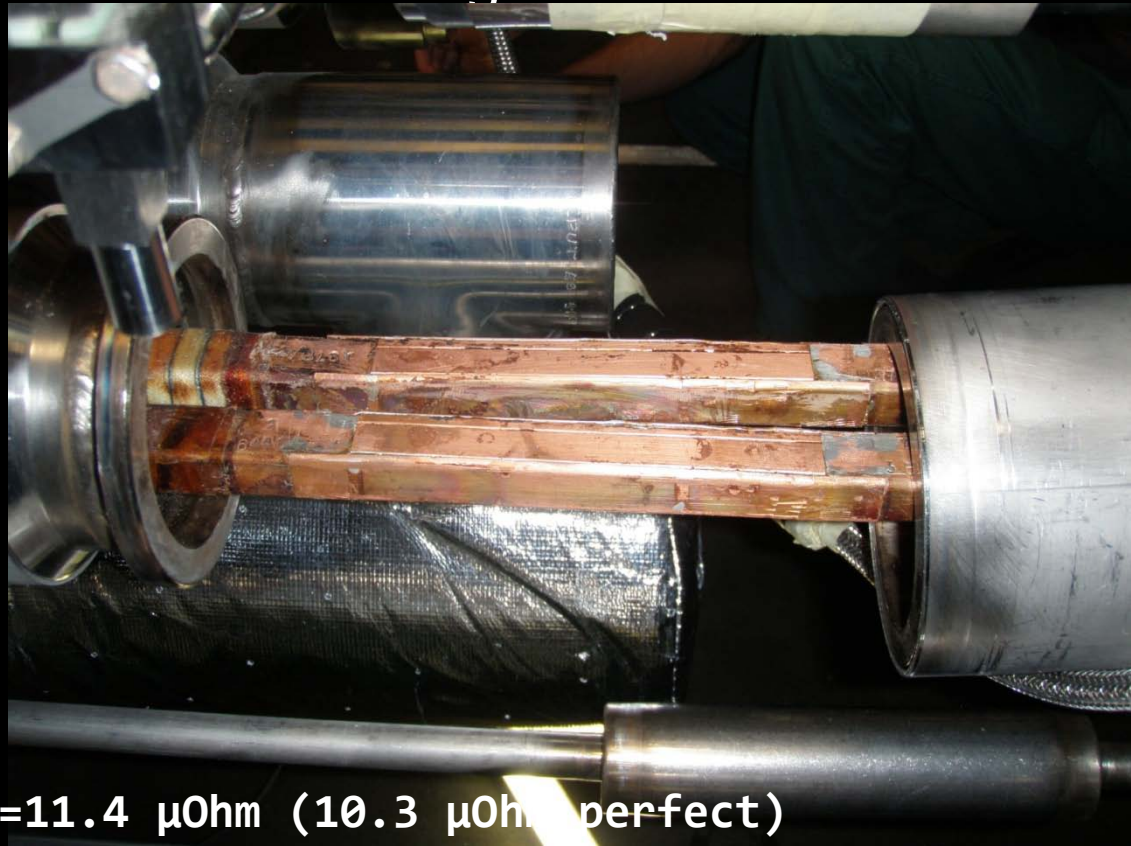
5. Splice quality control before de-soldering

QC results QBBI.A12R6 M3:

QBBI.A12R6-M3-corridor R-16=11.4 μOhm (10.3 μOhm perfect)

QBBI.A12R6-M3-cryoline R-16=11.2 μOhm (10.3 μOhm perfect)

US test 6 out of 6 above threshold for both splices.

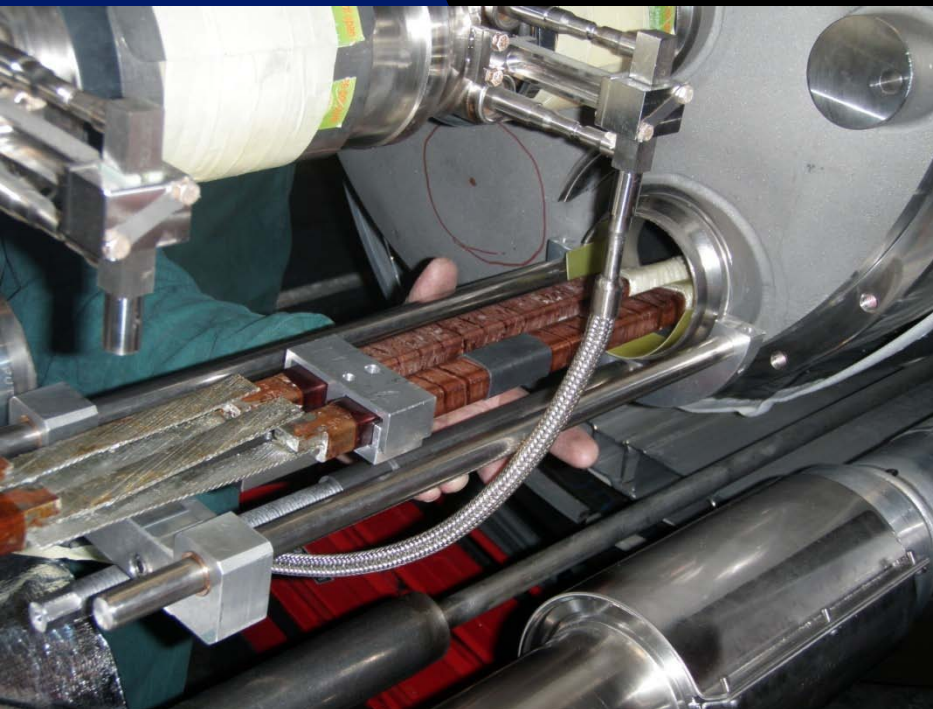
6. Splice de-soldering
7. Trials to reproduce the short

Lyra moved over working range
(and even more)
Resistance varied from a
minimum of 50 k Ω to G Ω but no
clear short

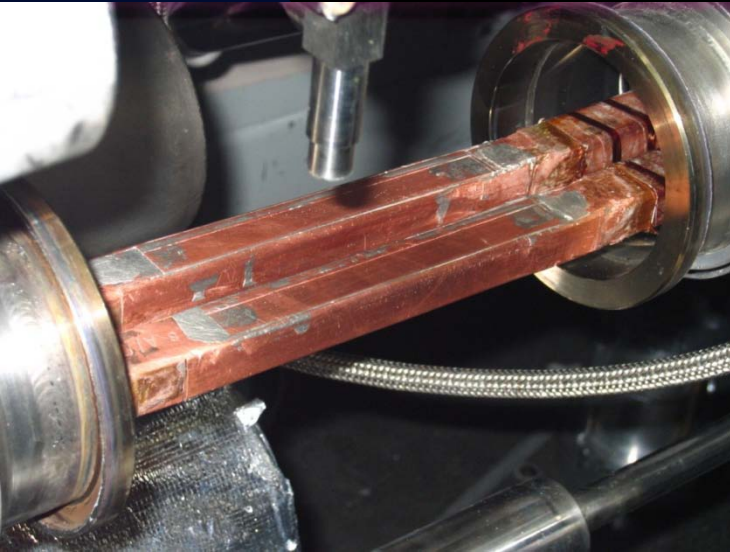
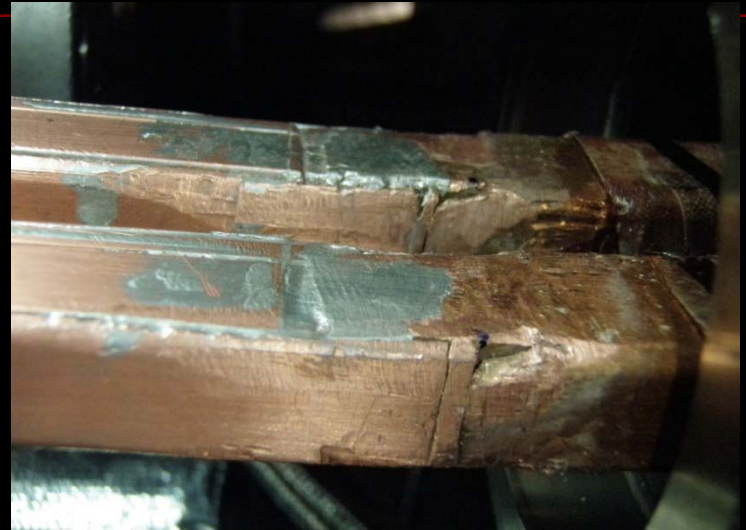
old

QQBI.11R6 M3 splices (SSS500 series)
