MMM - 13 July, 2009

Status Report of Magnet Work Week 28 / 2009

Francesco Bertinelli - TE/MSC

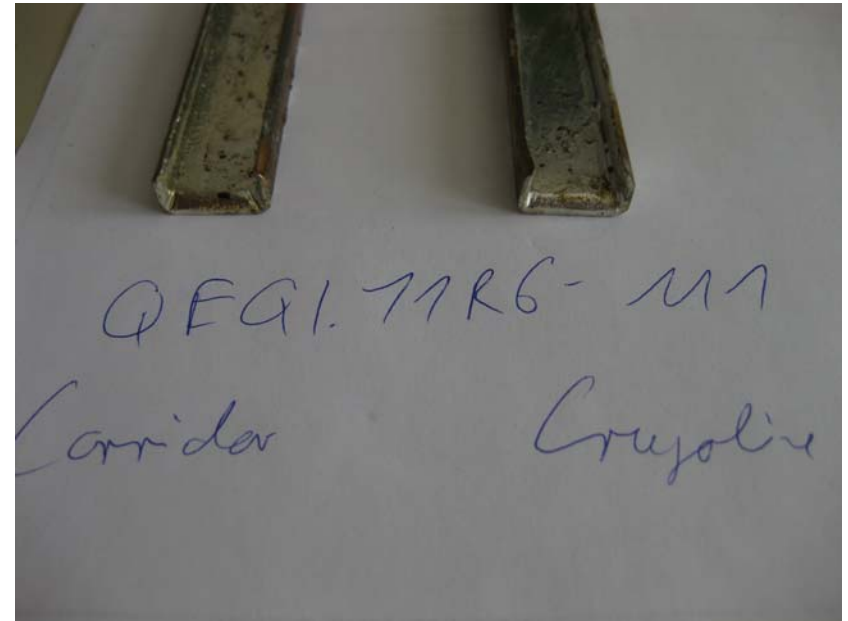
- Electrical Quality Control required last minute repairs on QEQL11R6 splices: found “chamfered U pieces”, probably associated to SSS Series 500 busbar repairs;
