MMM- 4 May, 2009

# Status Report of Magnet Work Week 18 / 2009

Francesco Bertinelli - TE/MS

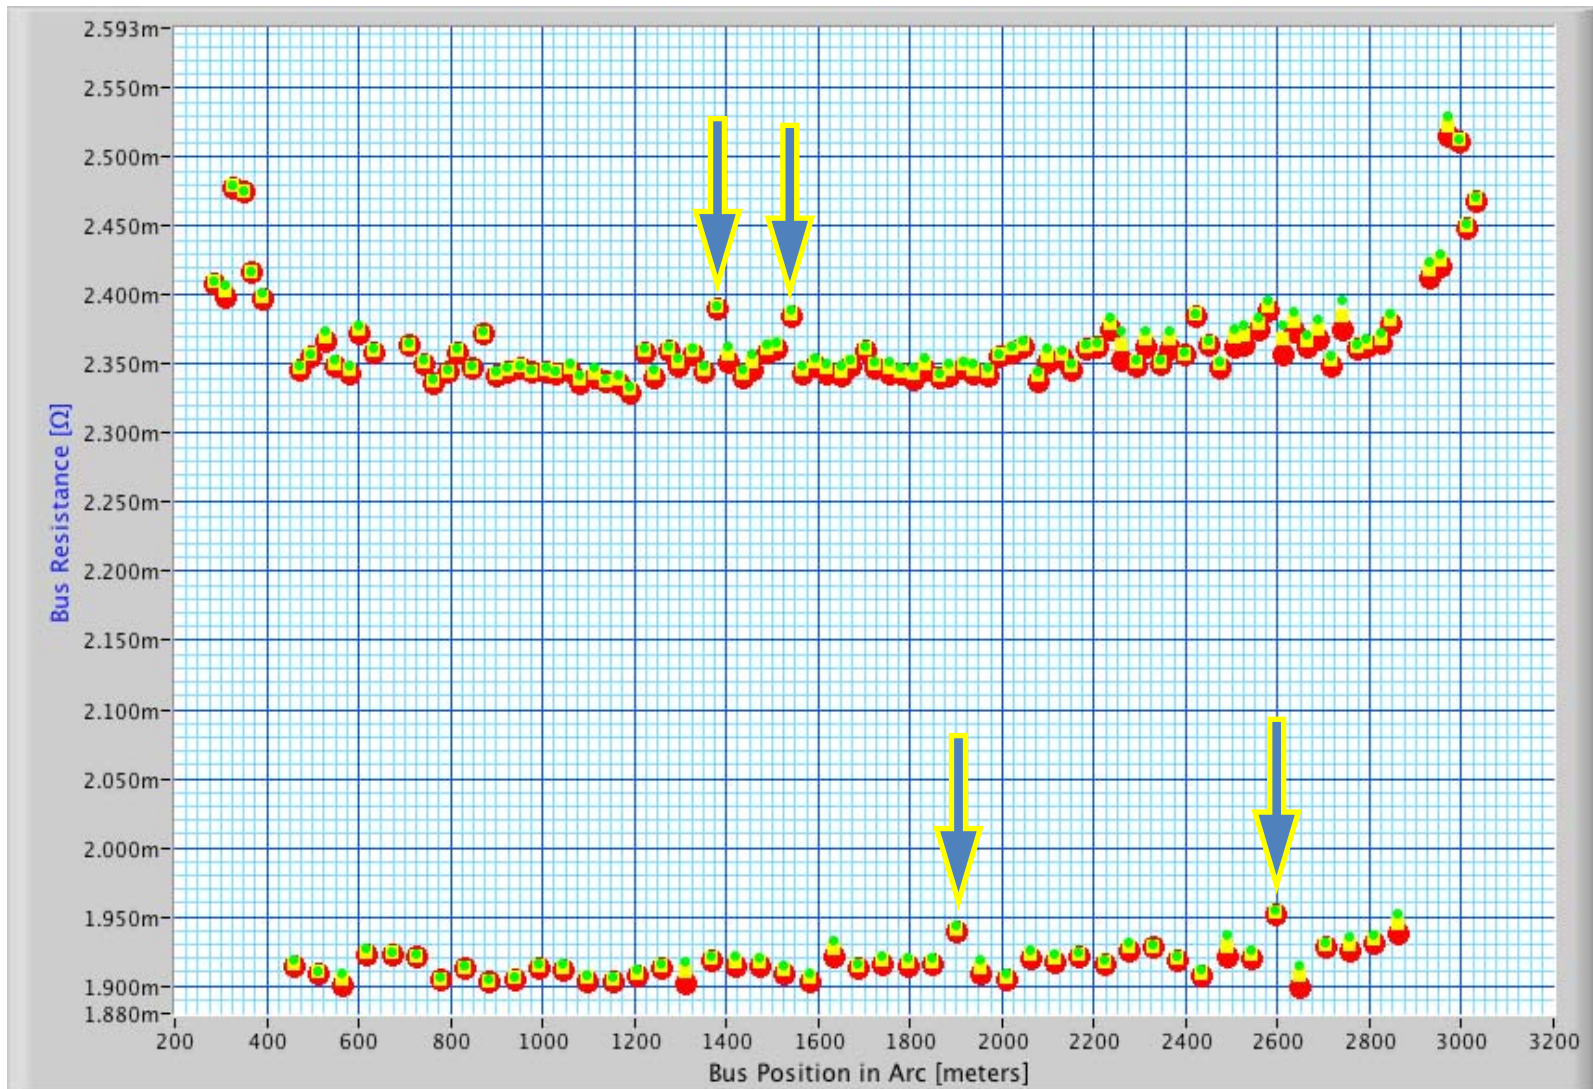
# 1-2 M3: copper continuity
