MMM and TEMB - 18 May, 2009

# Status Report of Magnet Work Week 20 / 2009

Francesco Bertinelli - TE/MSC

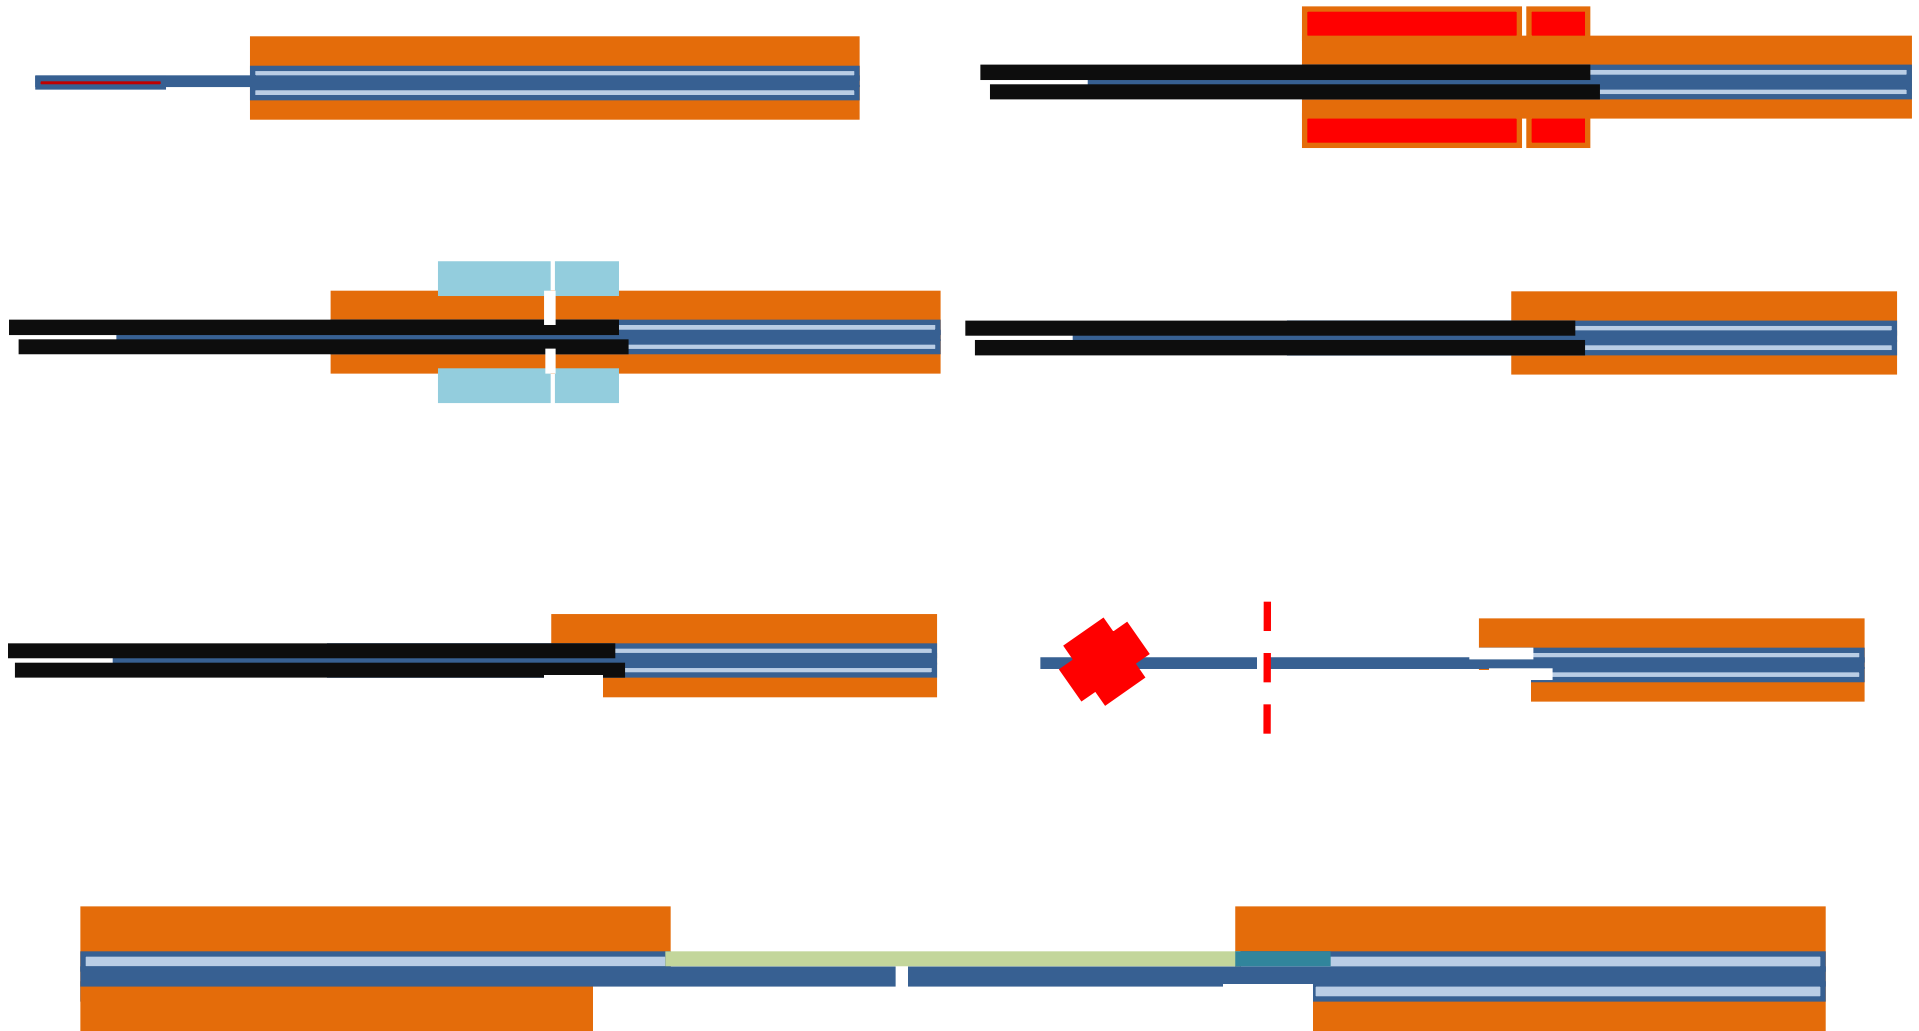
# Repair procedure QBBI.B29R3

- Some milestones:
  - Successful repair of overheated M3 cable (see Paolo)
  - Start of first jumper lines welding
  - End of electrical connections W20: 2 days later
  - Agreed procedure for NCR spools (MB2444 in C30R3):  
keep RCD corrector, condemn RCO corrector
  - Objective: MPAQ next Friday
- Cabling starting W21, warning on coactivity
