MMM and TEMB - 26 January, 2009

Status Report of Magnet Work Week 04 / 2009

Francesco Bertinelli - TE/MSC

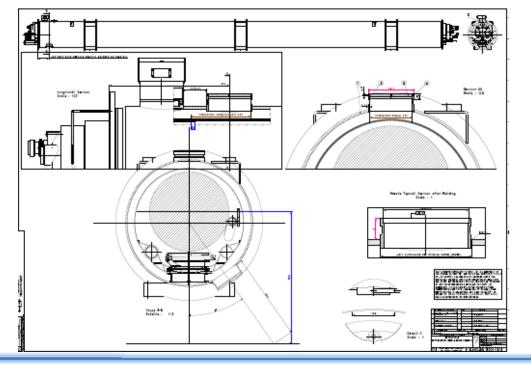
Risk of ignition of MLI from hot machining chips:

- demonstrate "no risk", conclusive test (wear of tool): NO!
- > open all W bellows: test Tuesday with IC screens in place. Would need S108 teams (cost, coordination effort, VAC effort, risk to O-rings and sealing surfaces ...)
- > move to -55⁰ position: test Monday morning
