MMM and TEMB - 6 July, 2009

# Status Report of Magnet Work Week 27 / 2009

Francesco Bertinelli - TE/MSC

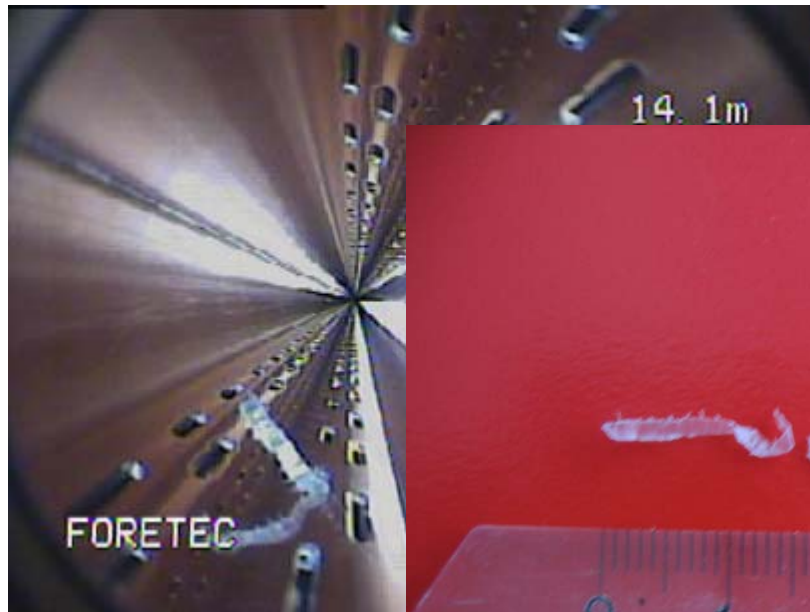
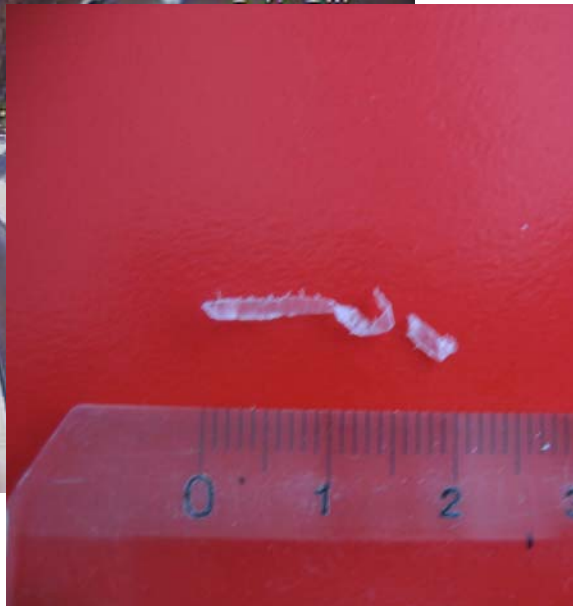
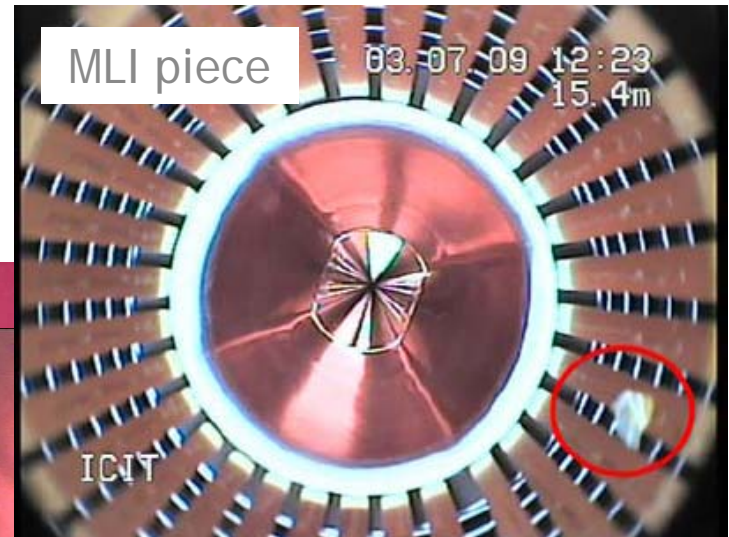
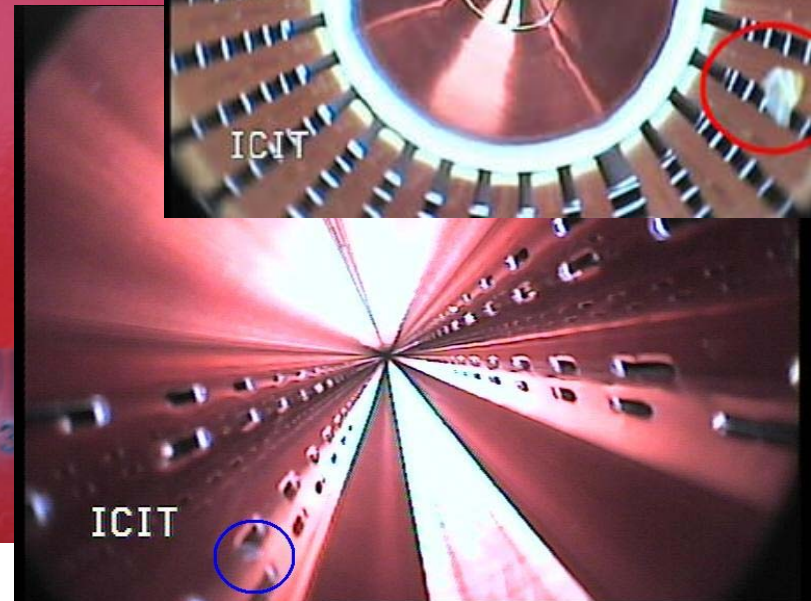
- PIM intervention required by VSC (old NCR 903606, QBQI.12R4, V1)
- ICIT removed most of plastic shim

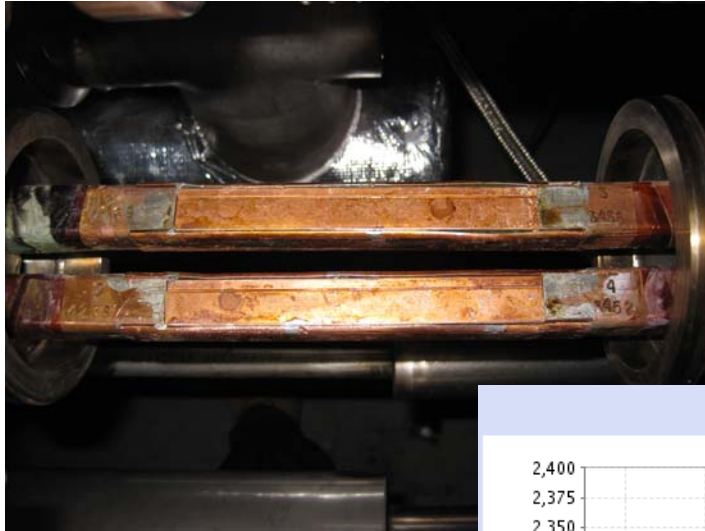
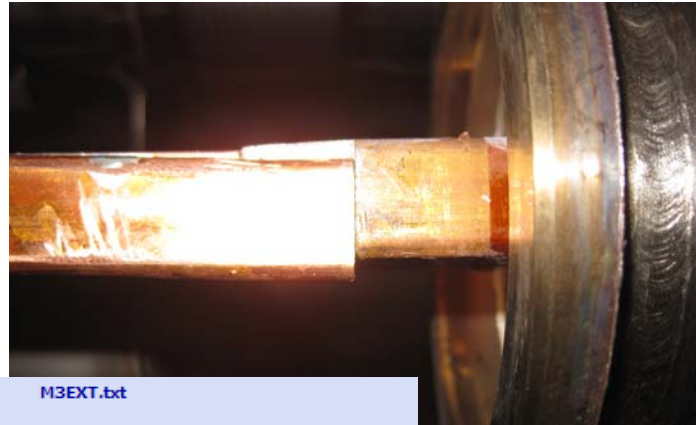
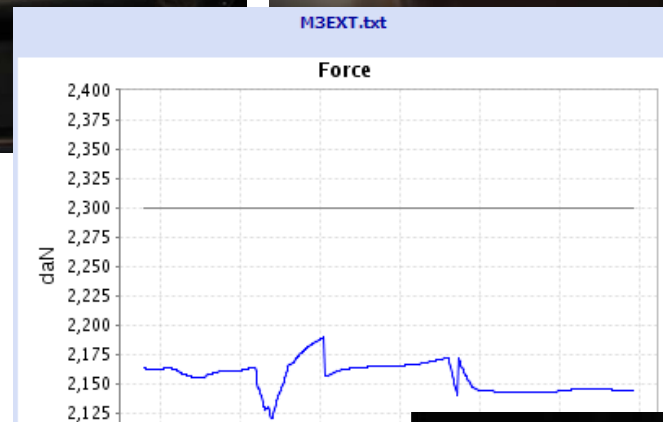
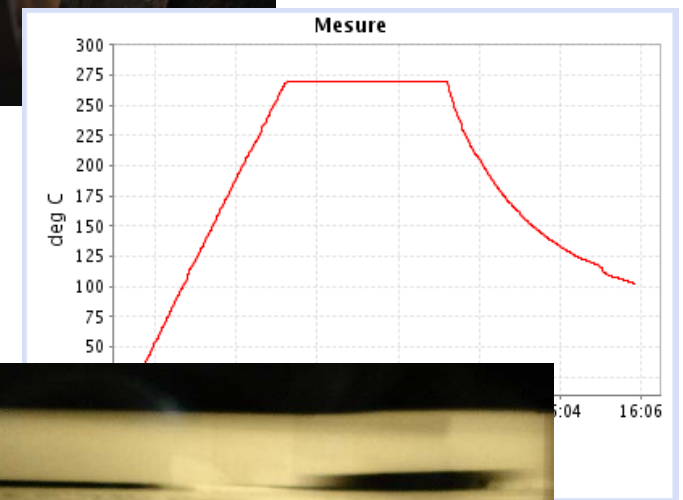
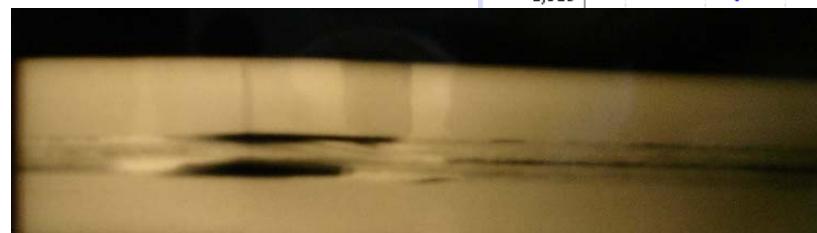
QBBI.A16L5 M3 cryoline - connection

# QBBI.A16L5 cryoline side
