# Sector 7-8 Consolidation

- ❖ Summary of activities
- ❖ Focus on interventions affecting the electrical circuits and their potential impact
- ❖ Connection cryostats
- ❖ Conclusions

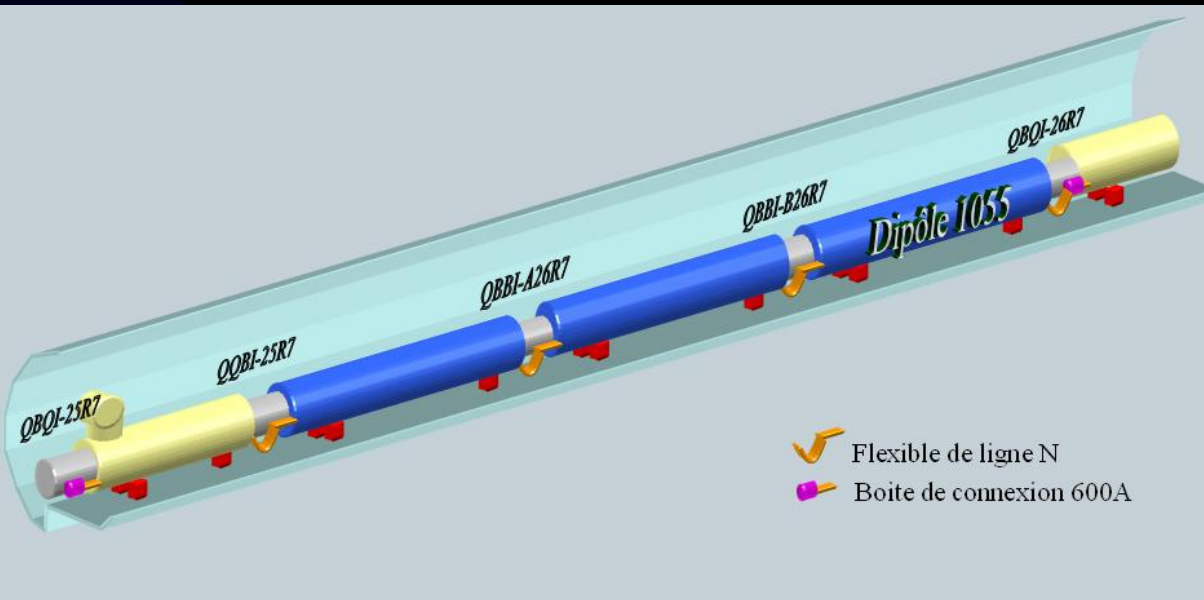
## Replacement of 1055 by 1334

### Affected circuits :

- Main dipoles (M3)
- Main quadrupoles (M1&M2)
- Spool pieces (M1&M2)
- Line N

Electrical qualification successfully performed after reconnection

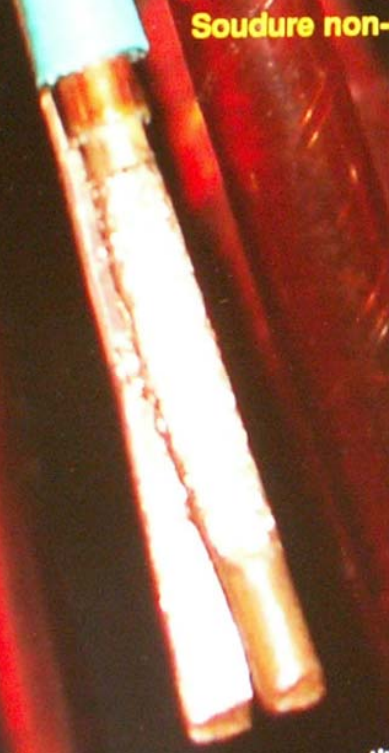
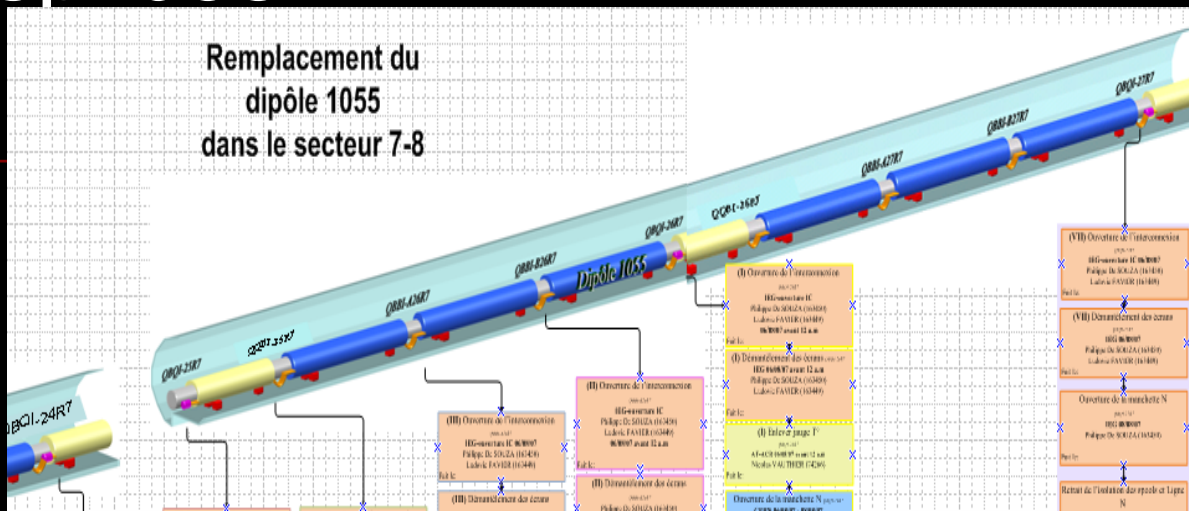
# Sector 7-8 Consolidation Line N splices

## 4 line N boxes open for replacement of cryodipole 1055 :

- \* Visual inspection carried out
  - QBQI.24R7 : 5 connection were corrected but no risk of breaking
  - QBQI,25R7 : No unacceptable NC but redone during normal activities
  - QBQI,26R7 : No unacceptable NC but redone during normal activities
  - QBQI.27R7 : 1 NC splice but acceptable as is
- \* Note : No evidence of “very” bad splice during HC tests

Electrical qualification successfully performed after reconnection

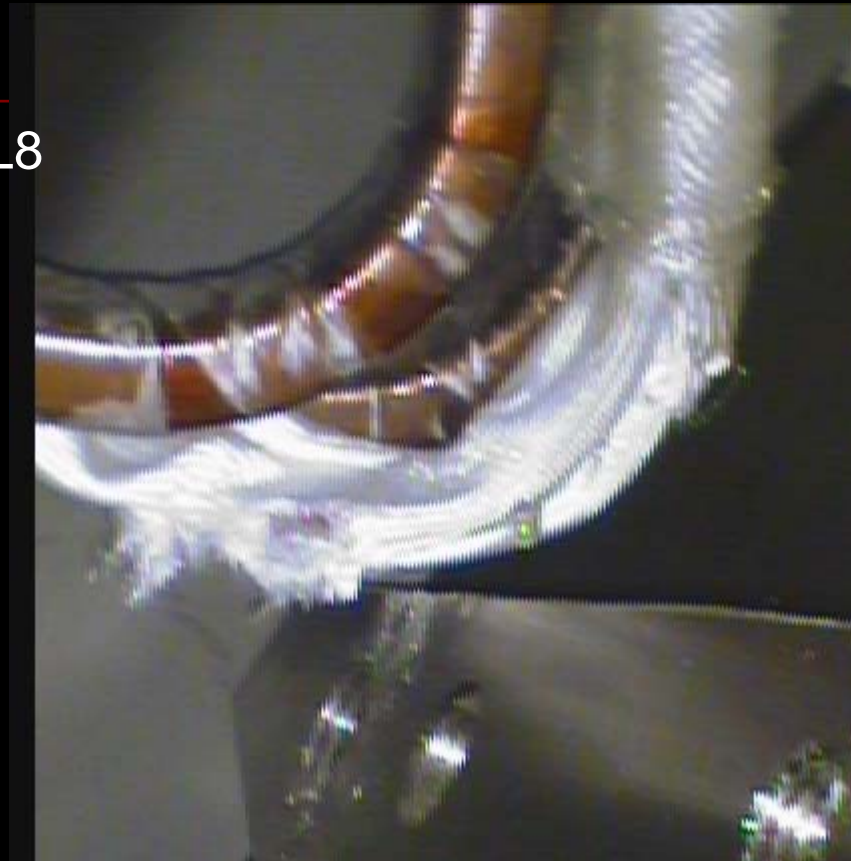
## SSS-500 busbars

6 units were concerned in 7-8 :

Q7R7, Q8R7, Q9R7, Q10R7, Q11R7, Q11L8

All BB have been shortened

Electrical qualification successfully performed after reconnection

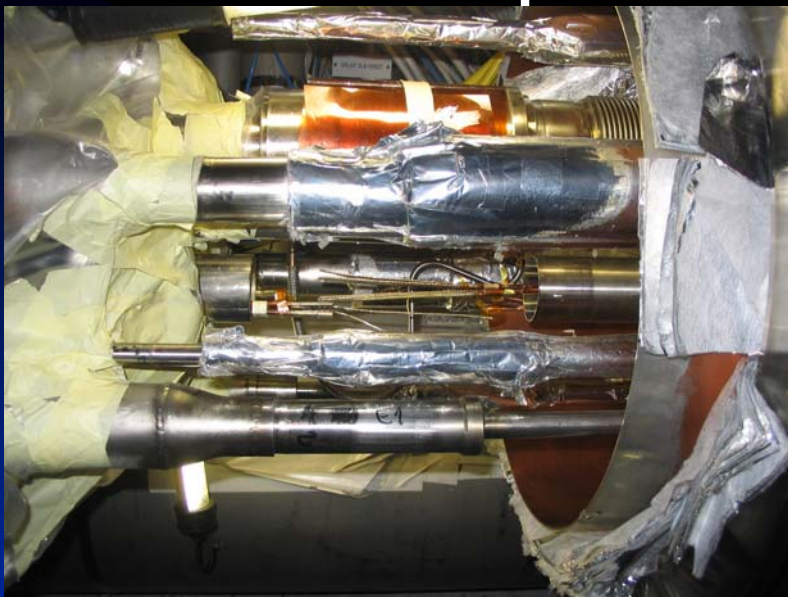
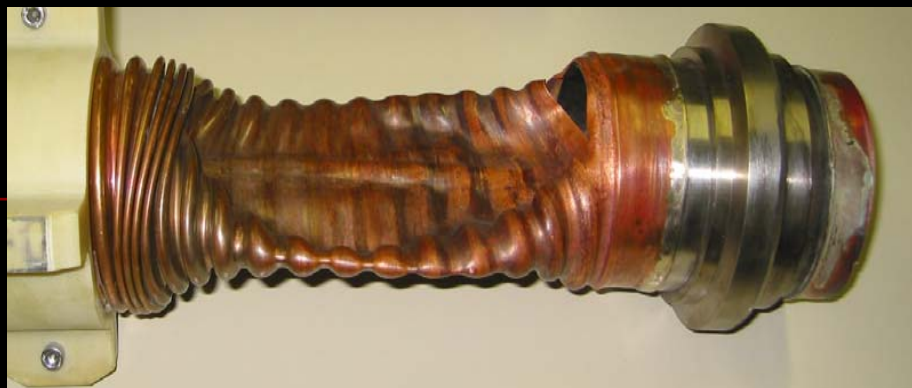
# Sector 7-8 Consolidation Triplet L8

## Affected circuits :

- All triplet circuits including D1 magnet

Electrical qualification successfully performed after reconnection

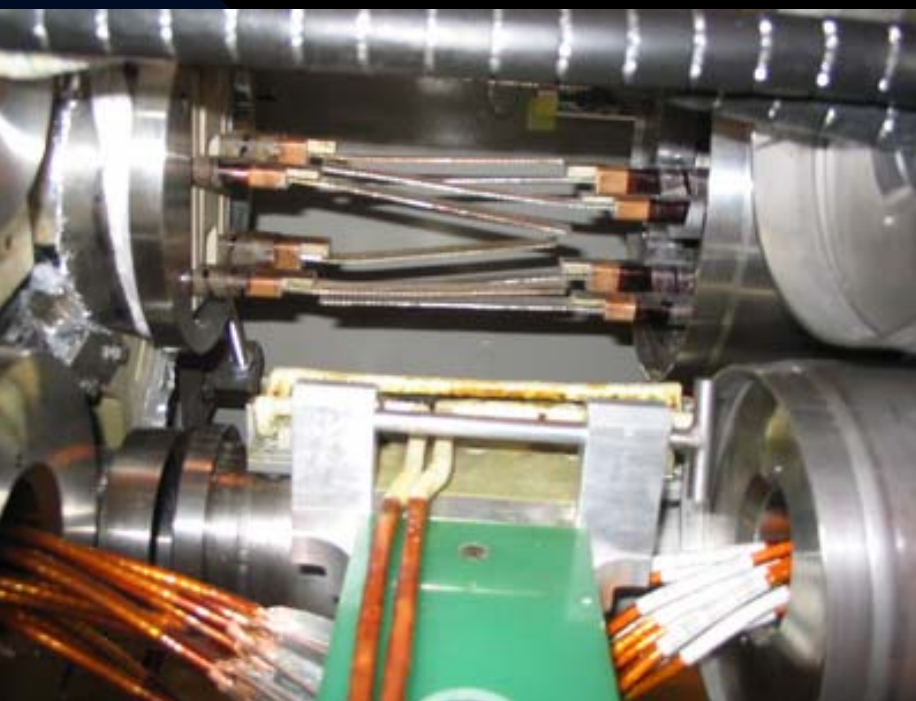
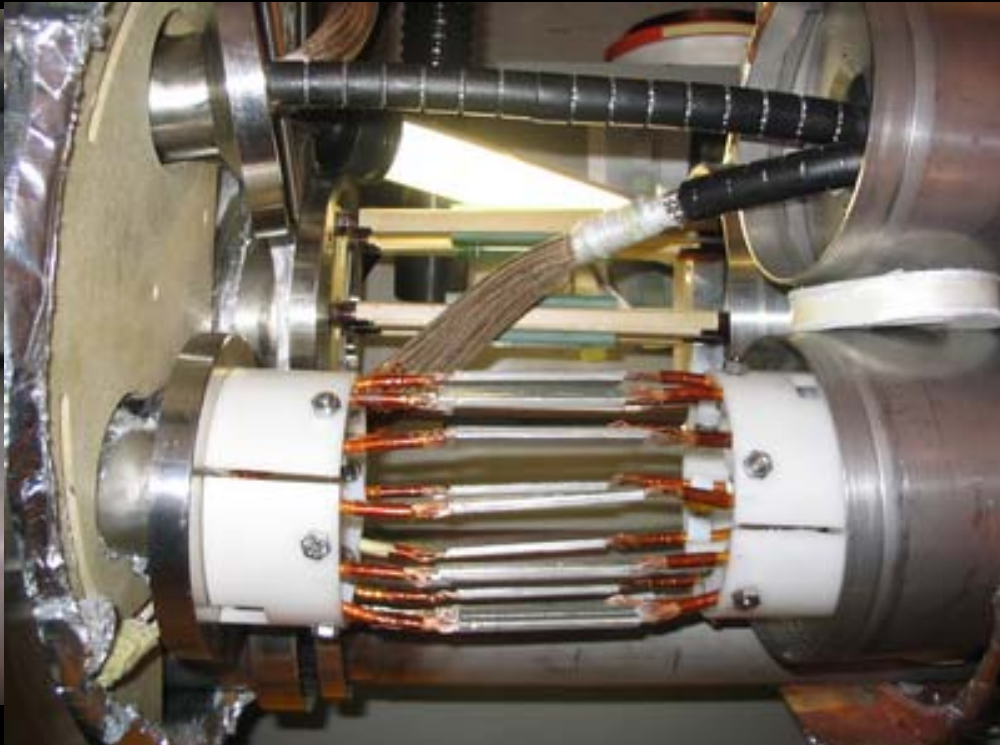
## Improve insulation on DFBAO 6kA splices

### Affected circuits :

- All 6 kA circuits powered from DFBAO (L8)

Electrical qualification successfully performed after reconnection

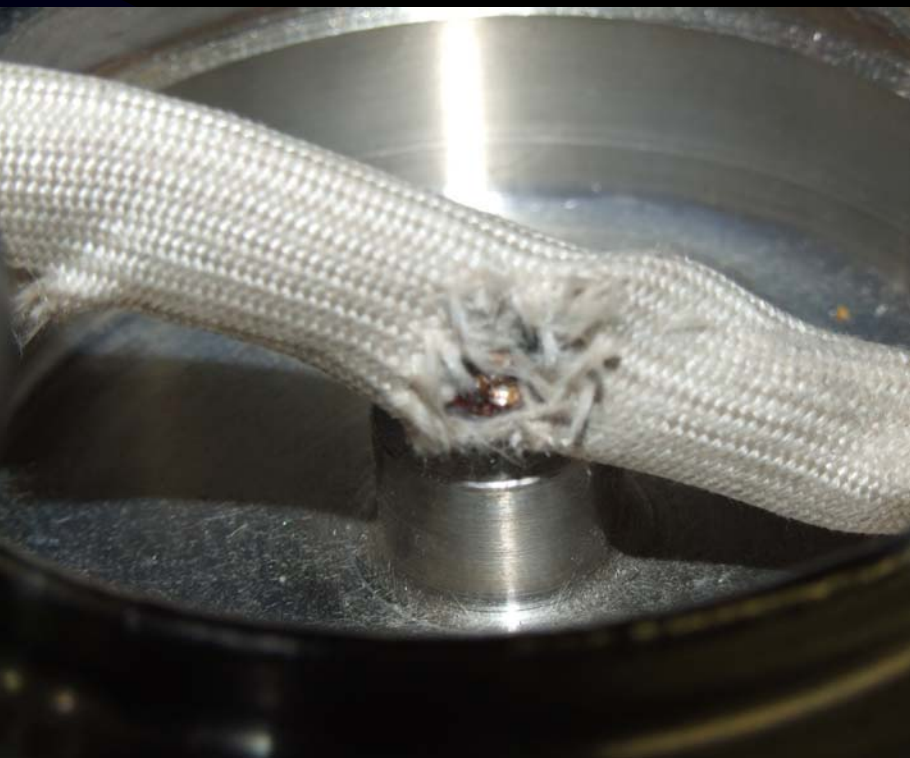
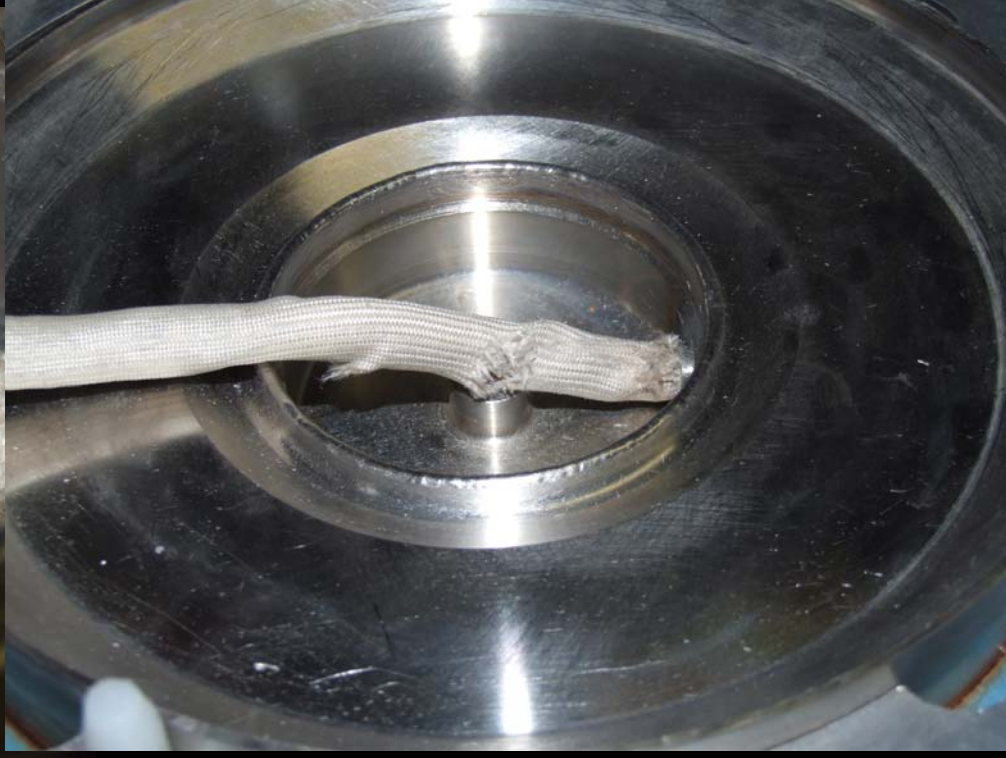
## Short circuit on 3006

IFS cut

Visual inspection revealed defect –

Repaired, tested, reclosed

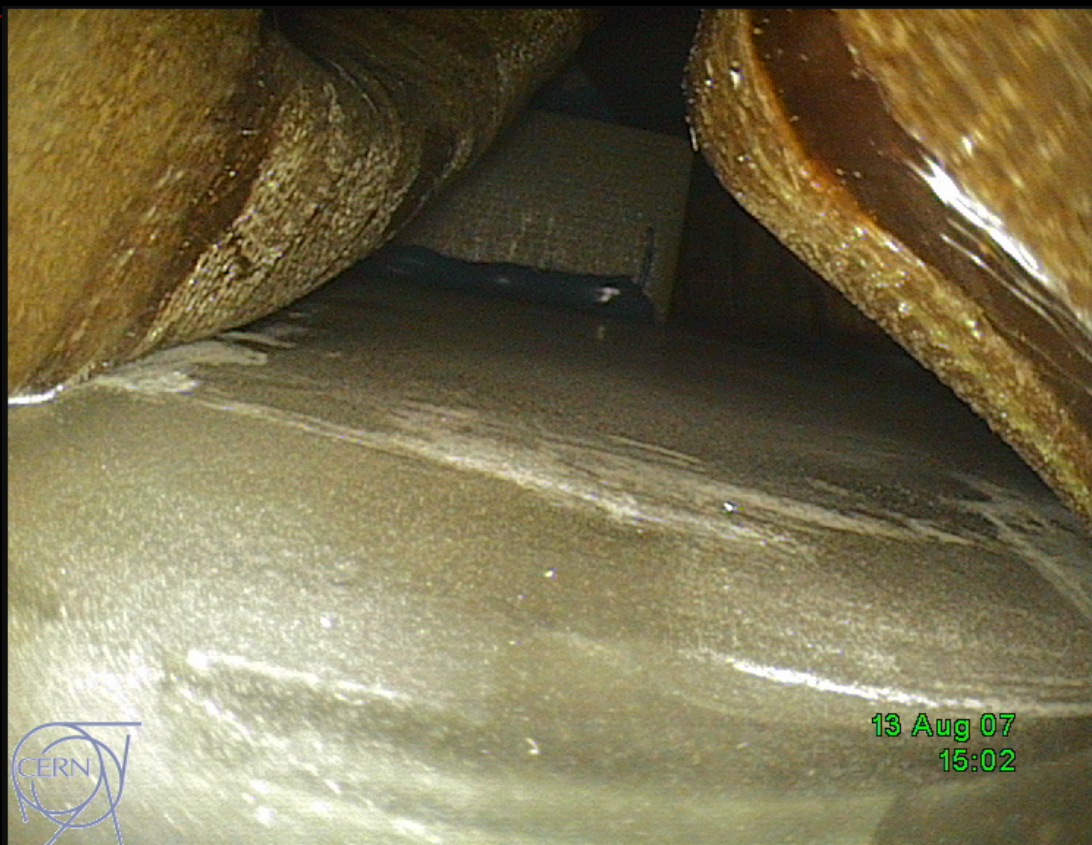
## Short on MQD circuit (Q22L8)

Reappeared during warm-up at same location and about same T as during cooldown

### Affected circuits :

- MQD
- spool pieces in M2 line

Electrical qualification successfully performed after reconnection

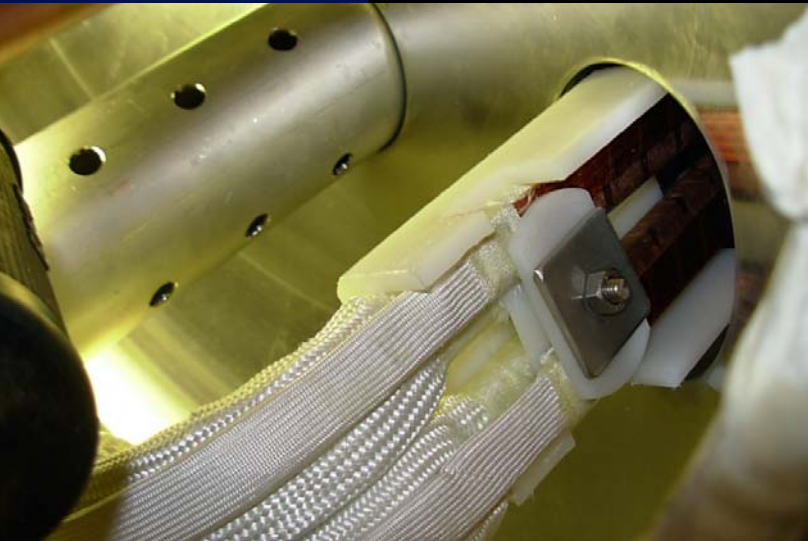
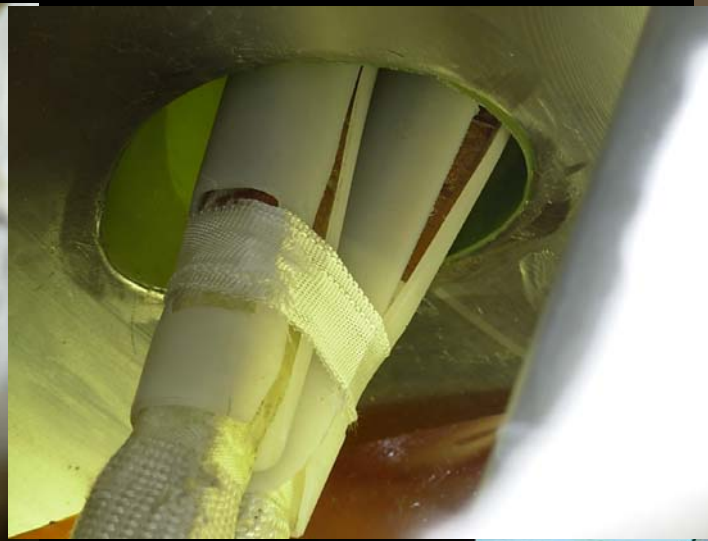
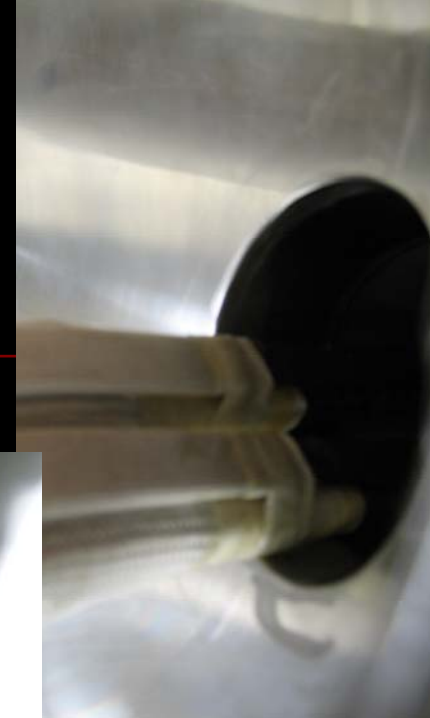
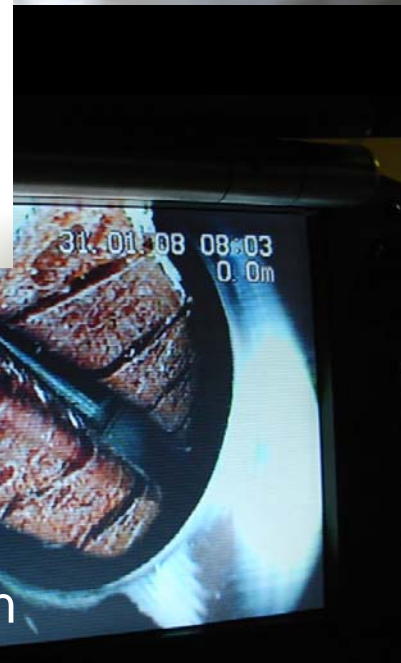
## Connection cryostats

+ Not during consolidation but after start of cool-down  
(February 2008)

### Affected circuits :

- Main dipoles (M3)
- Main quadrupoles (M1&M2)
- Spool pieces (M1&M2)

Electrical qualification successfully performed after reconnection
