Cryomagnets Interconnections

InterConnection Cryostats

MARIC
06/02/2008

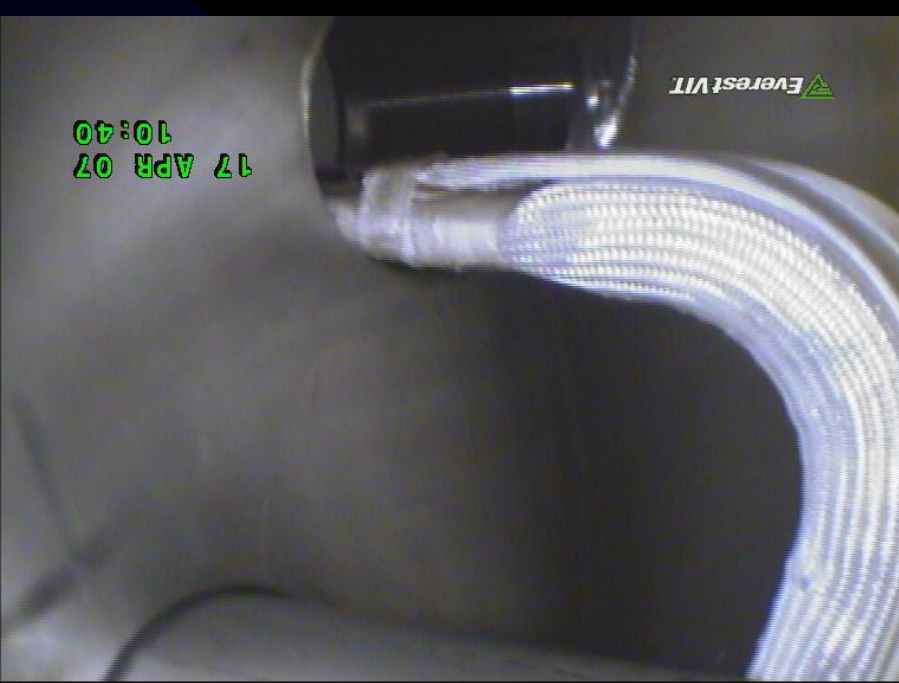
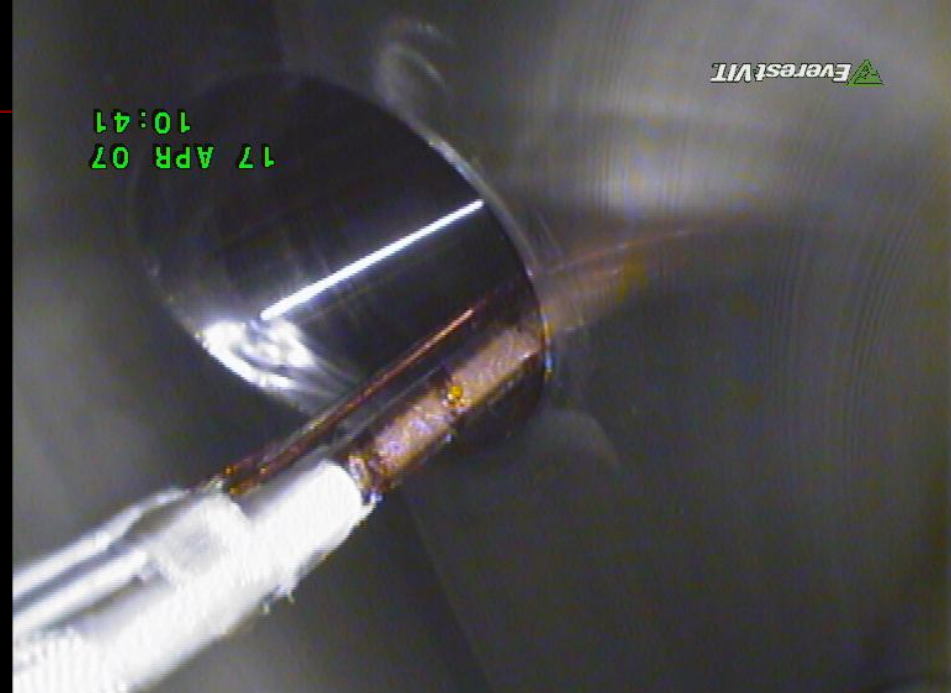
Previous endoscope inspections (8R)

This lead to the decision to open directly the shuffling module and not the adjacent interconnections

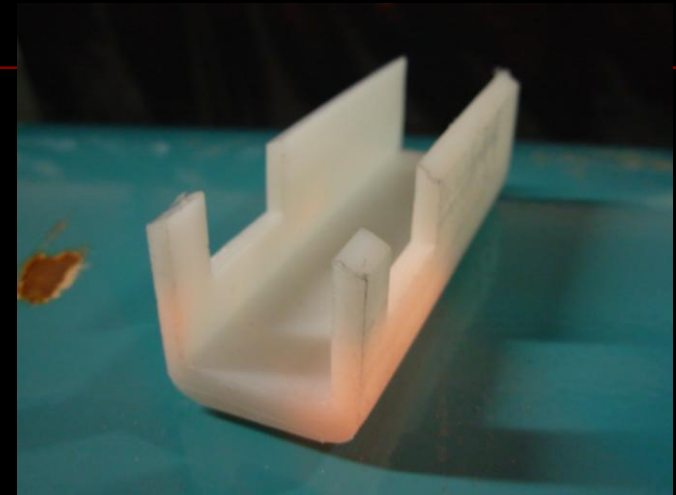
Intended for all busbars but not “mountable” on dipole BB

Reduced profiles for dipole BB – not possible to mount

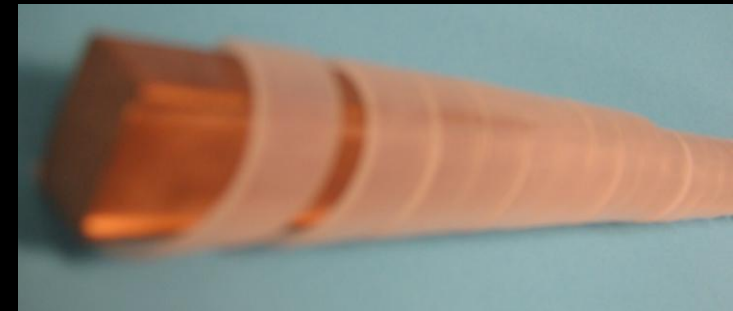
Plozip – not possible to mount in-situ

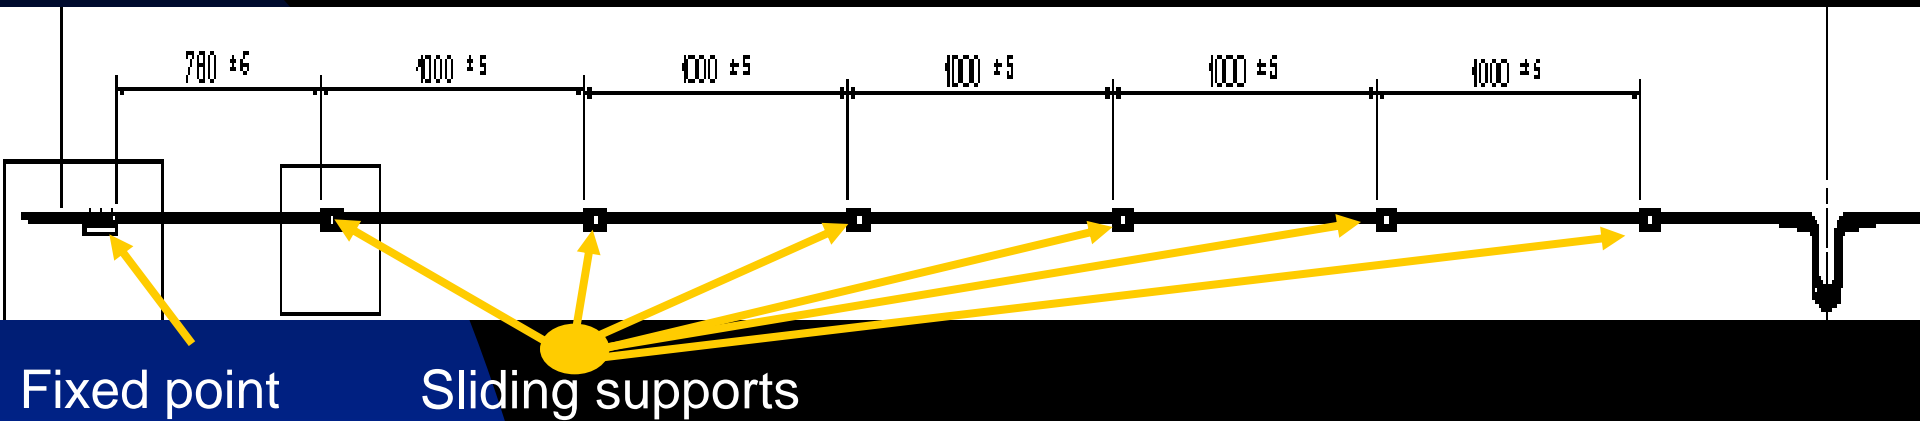
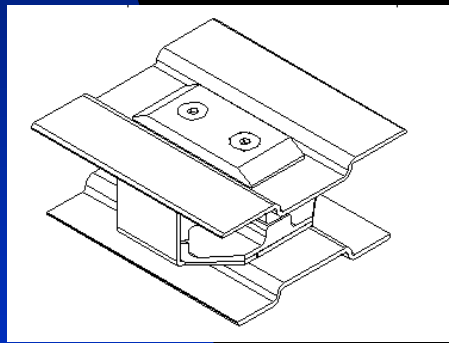
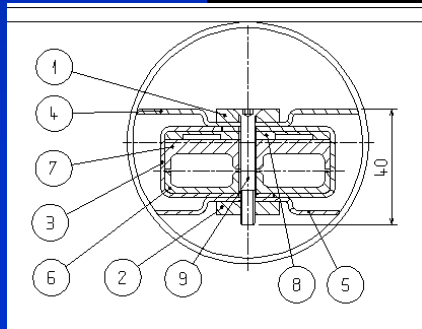
Origin of the problem :

Busbars were bent and touched the edge of the tube ; that created a short circuit ; This would have been avoided with sliding supports closer to the central end covers

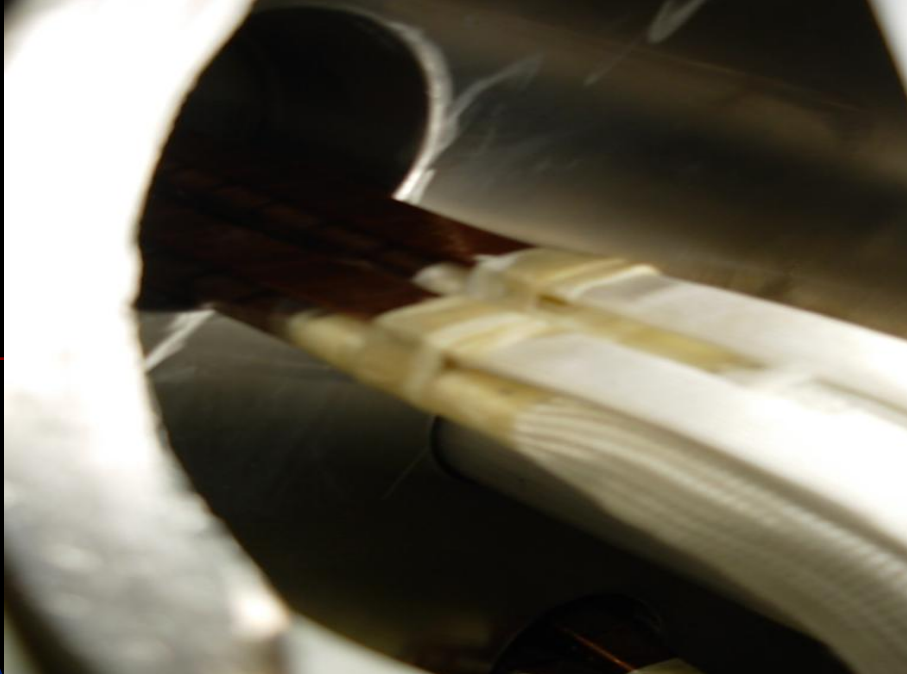
**Lyras pre-compressed,
As seen in CC11L8**

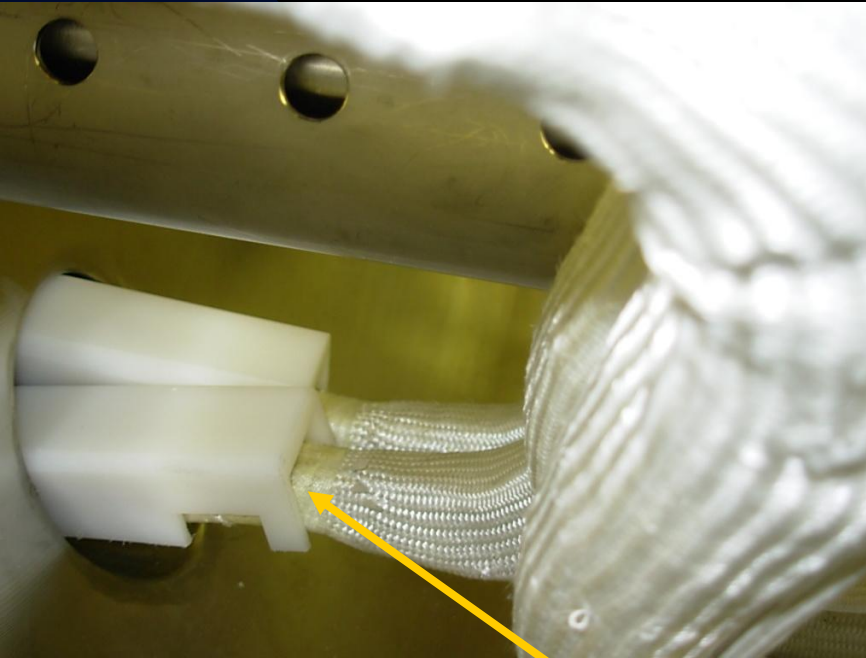
Reinforcement of electrical insulation :
Dipole busbars [To be validated in-situ]

Not satisfactory for the U shapes PEHD profiles

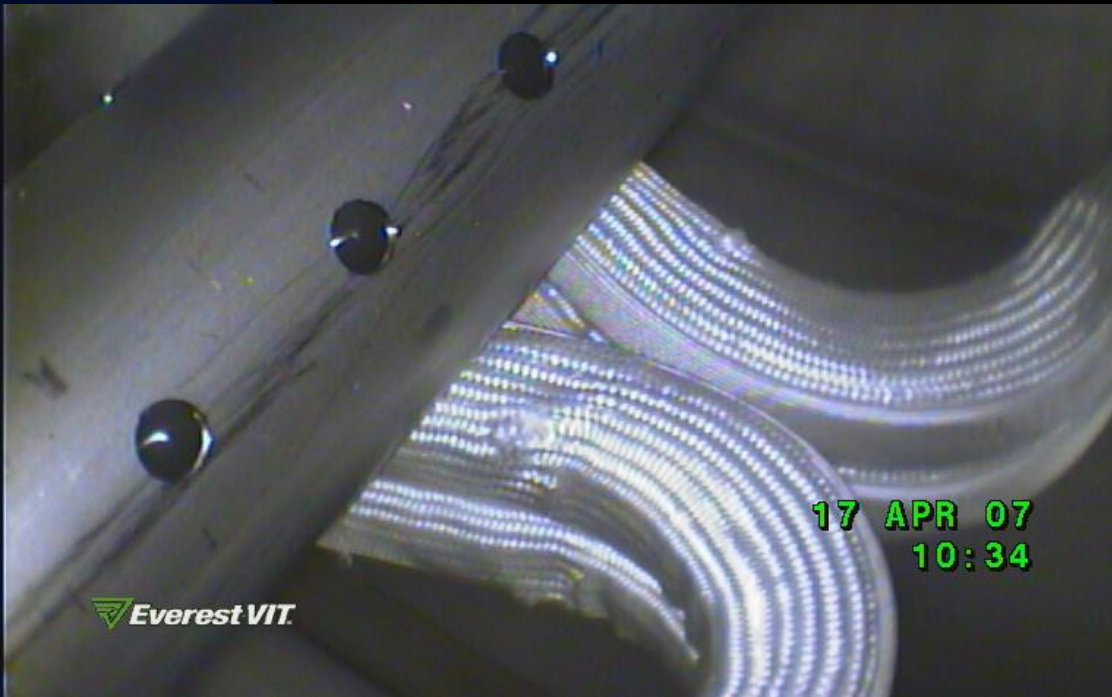
Lyras [To be finalised]

Plozip can not be installed

Solutions to insulate lyra OR the V' tube are under finalisation ; the best will need to be selected (dish around lyra or ... or ...)
