## LHC Arc and Special Interconnections: update

F. Bertinelli / AT-MCS

- Connection Cryostats repair
- Study for possible DFBA cable intervention
- Other points

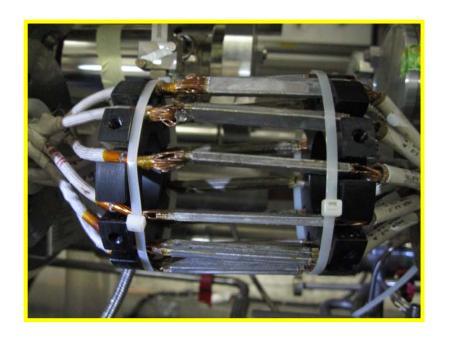
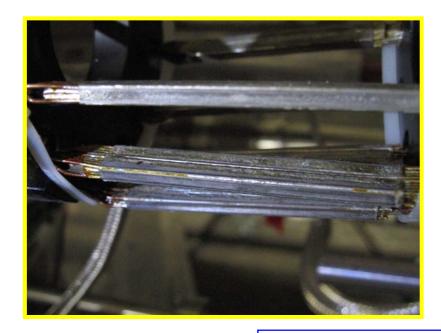
## Study for DFBA cable intervention

- Mock-up being prepared (for end wk. 11/2008)
- Difficult and risky:
  - debraze (doubly overlapping cables, crimping plate)
  - new insulating inner piece
  - damage insulation, pulling cables etc.
  - do only if <u>really</u> necessary (but if so, better now than later)
