STATUS of 7-8 consolidation

F. Bertinelli / AT-MCS

ICC: 21 September, 2007

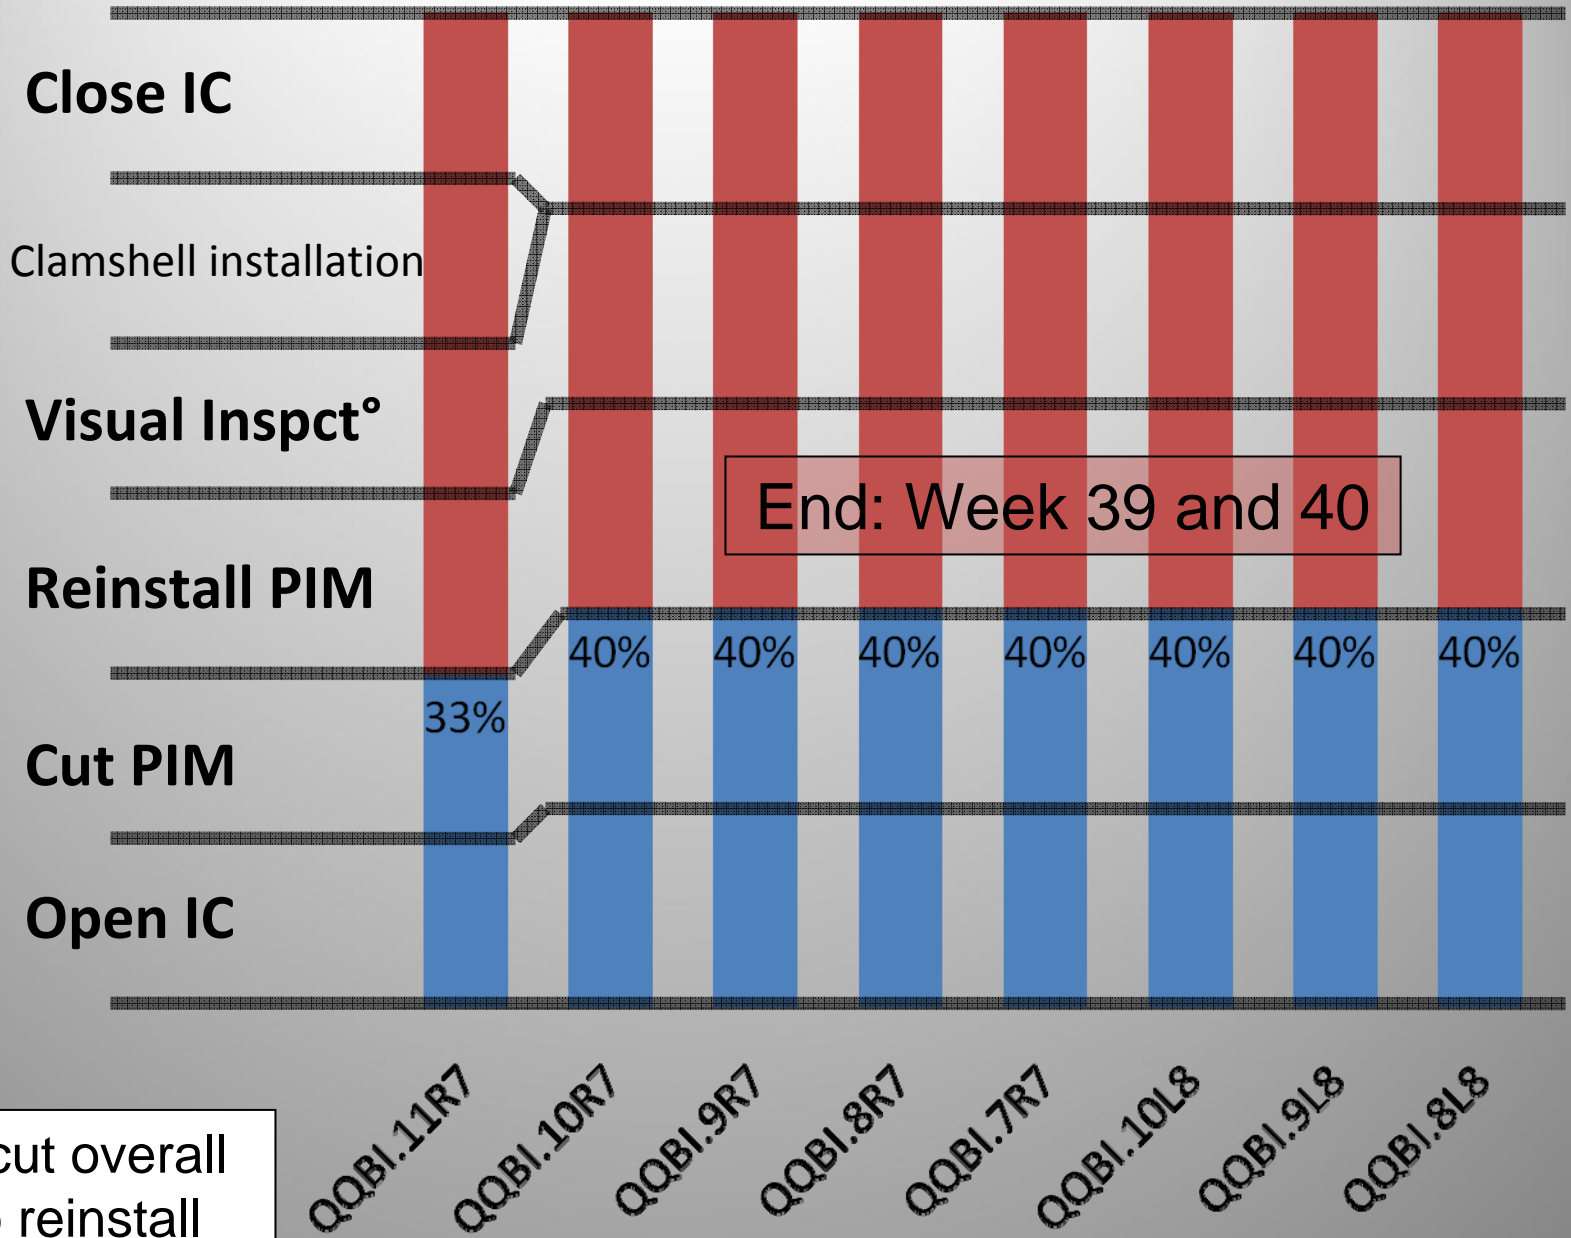
PIM

- 31 PIMs cut overall
- 2 week to reinstall

STATUS of PIMs

- The order for reinstalling the PIMs will be from R7 to L8.
- Replacement PIMs need ad-hoc machining (VAC support please).
- Some PIMs already machined (15 DS region, 4 arc replacement MB1055): assembled with RF fingers will become available for the end of wk39 (VAC: careful with types!)
- Installation (VAC support please) starting 27 September, IEG tacking and welding.
- QQBI.7R7 and QQBI.8L8 installed last to leave a short time window (1 day) for an eventual global ball test.
- Remaining 12 arc PIMs: need to be machined (VAC support please), and RF finger assembly to be available end wk 39.
