Cryomagnets Interconnections

❖ Connection Cryostats [See also MARIC 06/02/08]

❖ Consolidation of sector 4-5 [See also MARIC 23/01/08]

❖ Sector 1-2 : Jack/Ground fixation

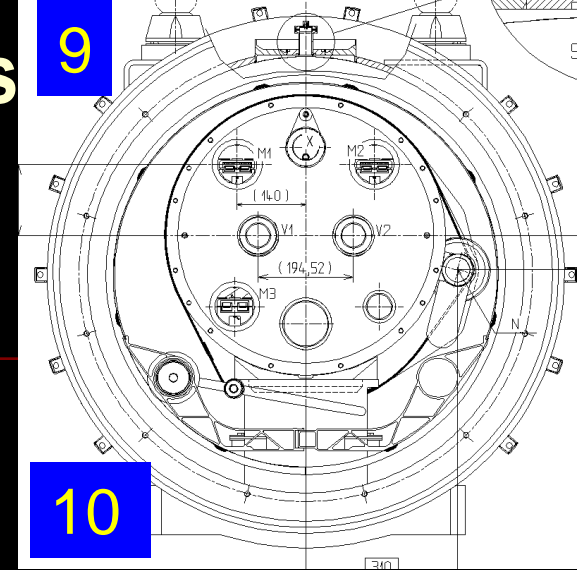
9

-Problem : Deformation during welding

Test done on a cryostat in SM18 (About 1.5 m banana shape !!)

Compensating welds on opposite side ... Minor effect

Reduced opening and weld geometry to be adapted for next ones

Correct position back by acting on central foot or the whole cryostat ?

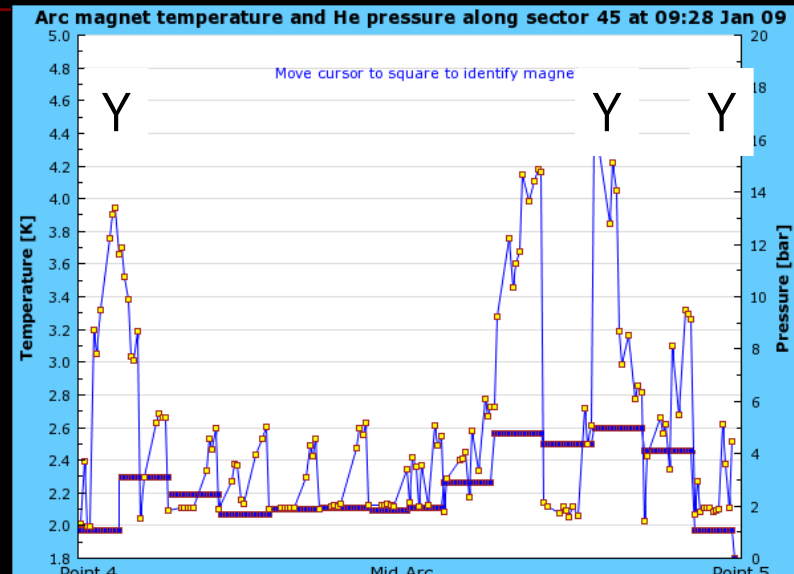
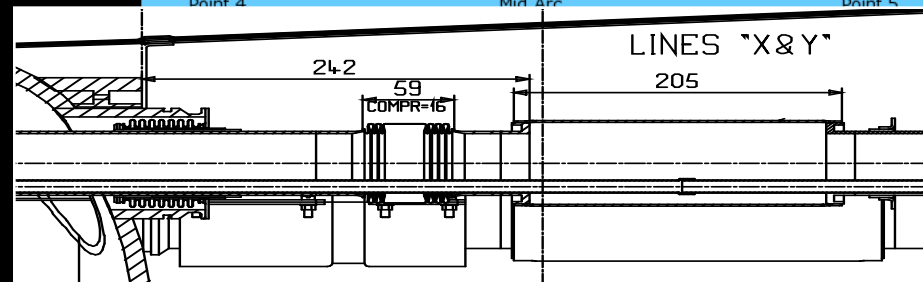
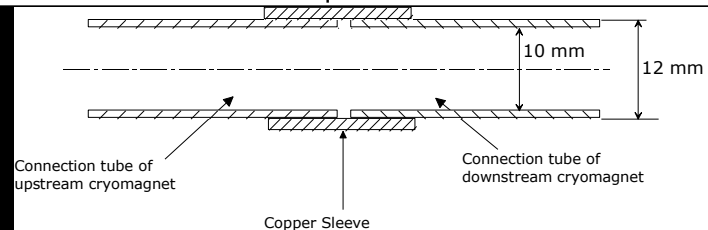
Y-Line to repair (#2 or 3)

- 3 locations : Q10-Q11R4 : QBBI.11R4 (TBC)
Q18-Q17L5 : QBBI.B18L5 (TBC)
Q9-Q7L5 : QQBI.8L5 (TBC)
(No line Y in Q7 by design)
- Analysis of data allowed to localise the most likely place of the defect [No need for extra time]
- Opening of IC and line X
- Endoscopic inspection
- Repair – Test – Reweld line X – Leak test
- Reclosure of IC

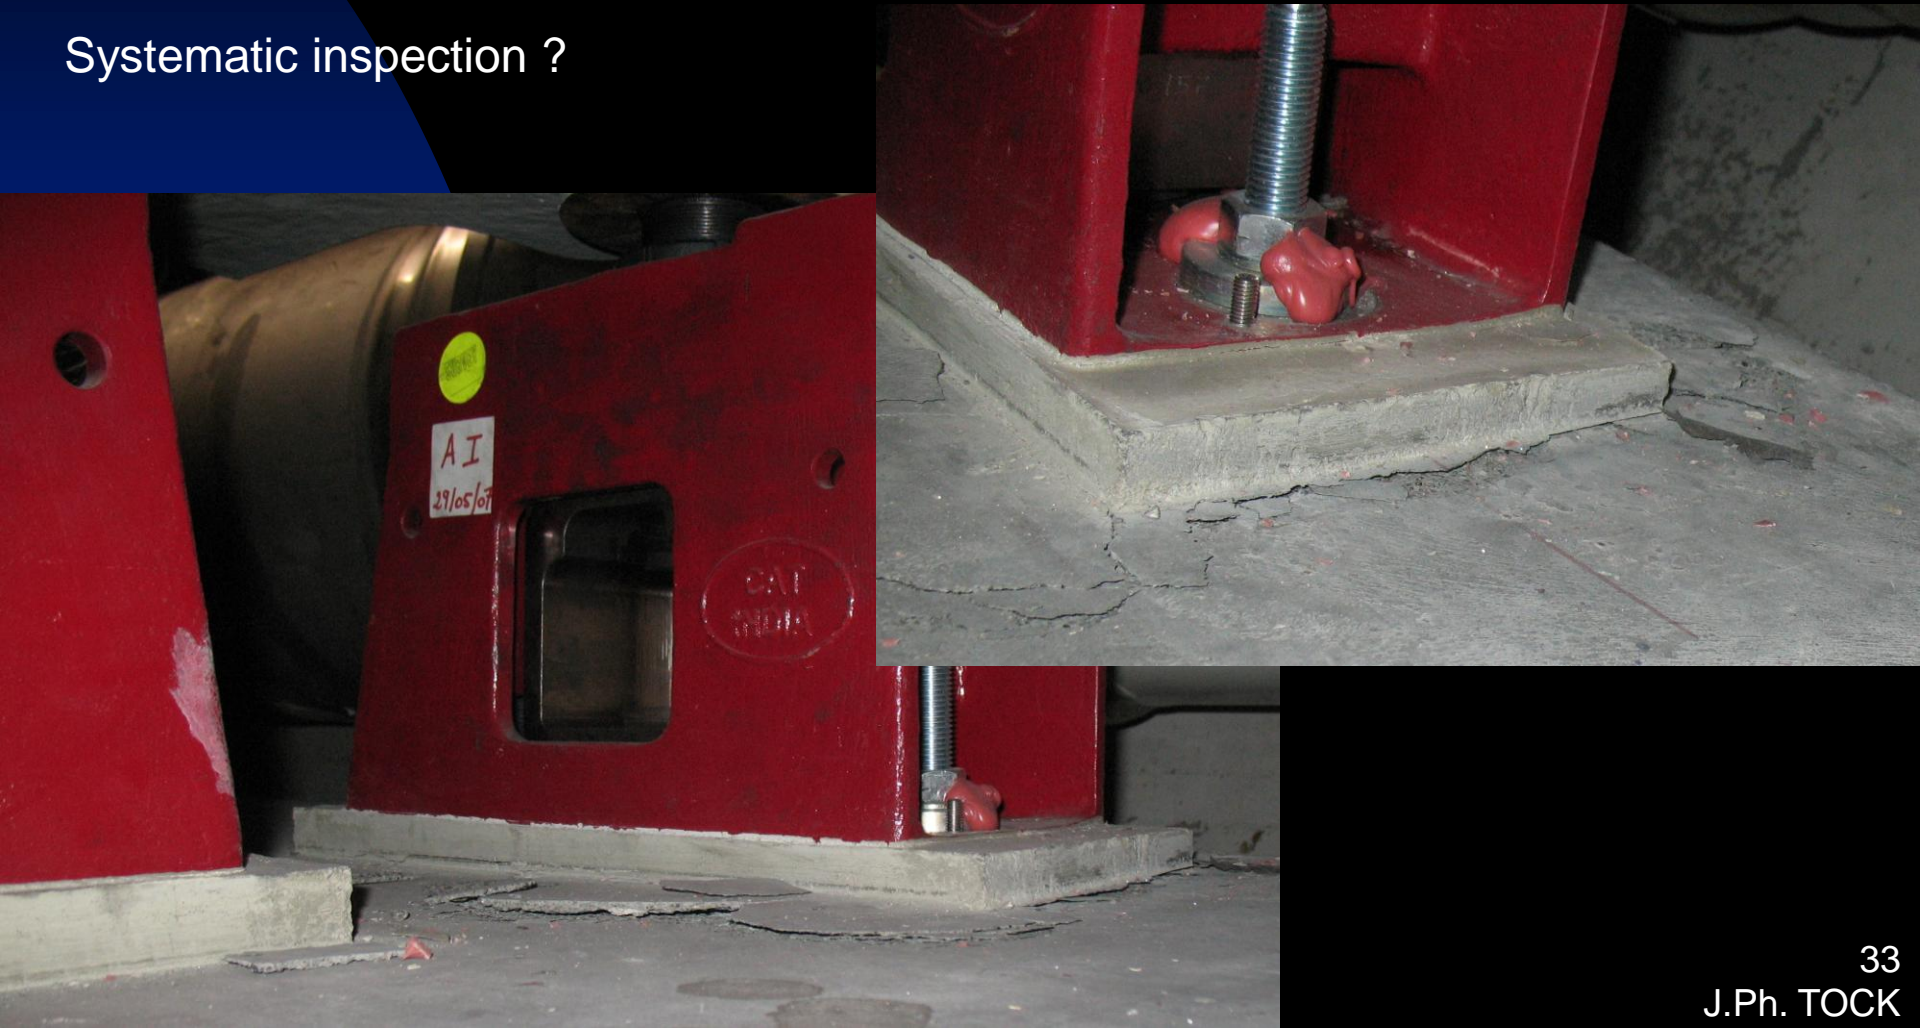
Sector 1-2 : Jack/Ground fixation

IC QQBI.19L2 : Displacement of :

Tilt : 1.5 mrad ; Longitudinal : - 5 mm

Vacuum barrier in the neighbouring SSS

Systematic inspection ?
