# Cryomagnets Interconnections

# (Inter)Connection Cryostats Status

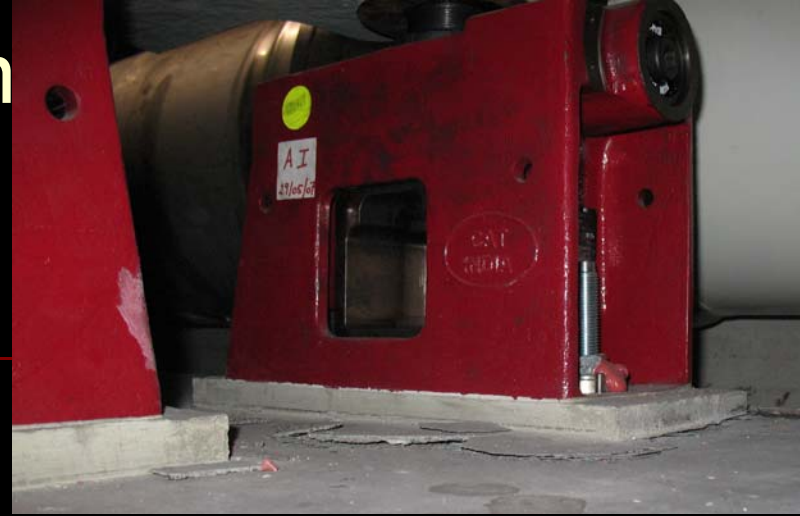
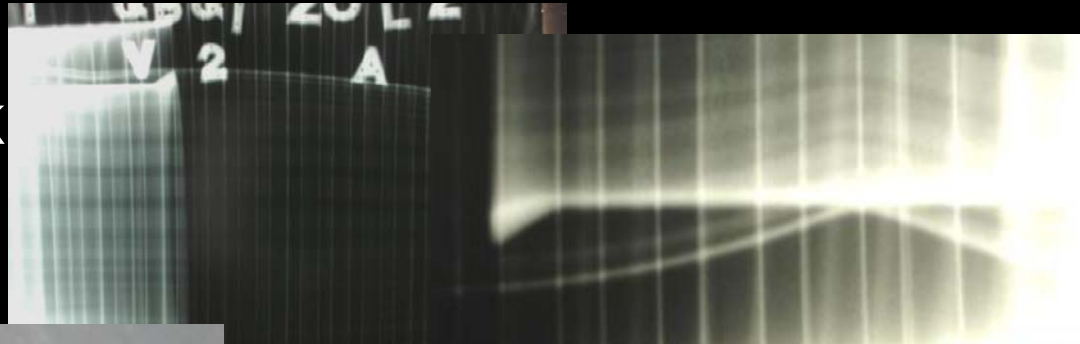
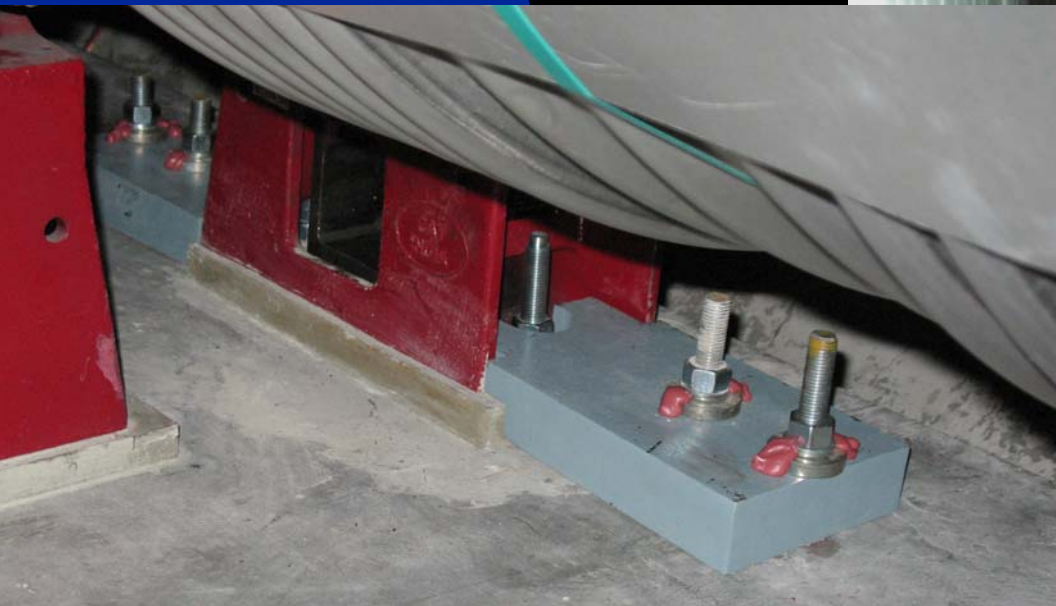
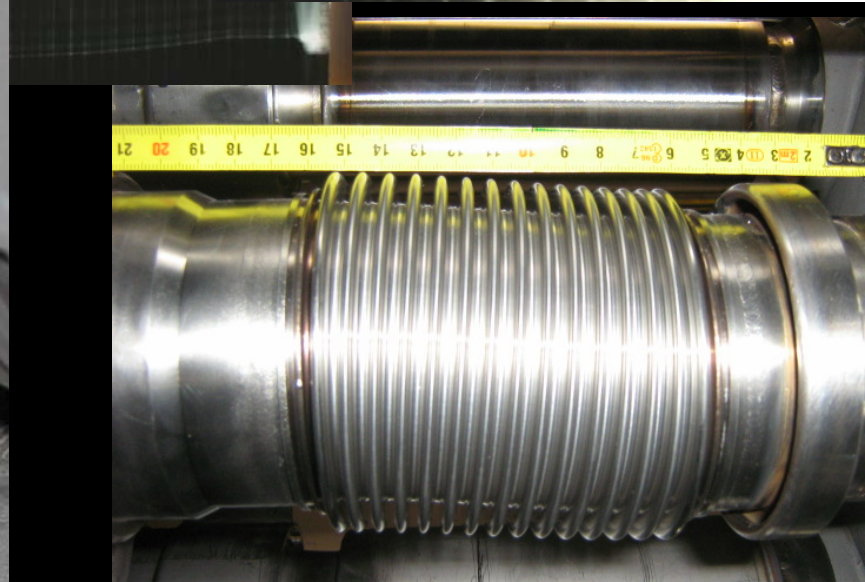
- Q19 L2 : [Documented in NC 890391]
- Displacement of : Tilt : 1.5 mrad ; Longi. : - 5 mm
- Systematic inspection launched by TS/IC
- Gamma-rays of PIMs : OK
- Concrete was repaired [TS/HE]
- Test with vacuum on one side : OK
- Busbars bellows deformed
- Coincidence ?

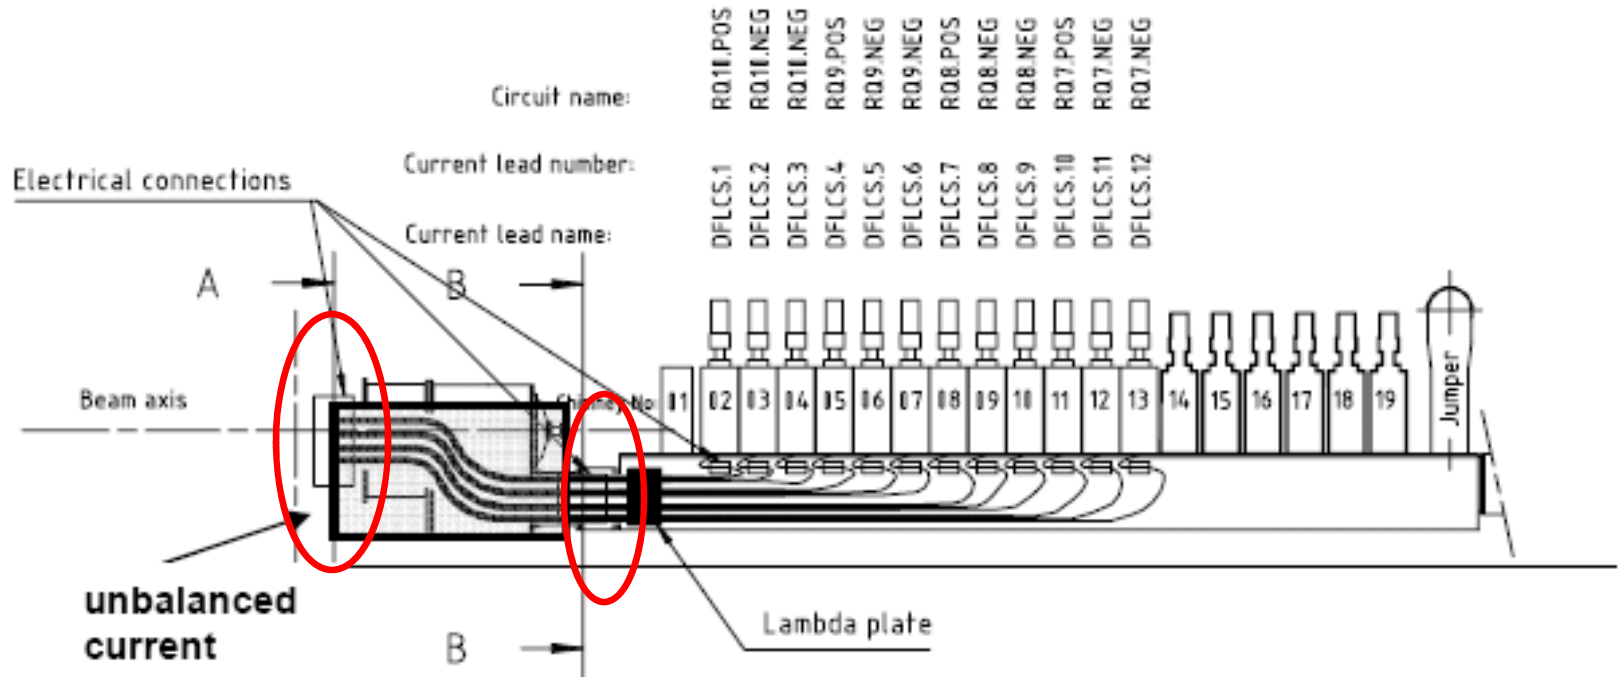
Figure 1. Schematic view of 6kA busbar routing in DFBA

- Intervene on the left/right sides of the ATM modules of the DFBAs, DFBLs and DFBLMs
  - ◆ Q7 to ATM module
  - ◆ ATM module to HCM module
- Disconnect up to 5, out the 12, 6 kA connections
- Reconnect them with correct arrangement/grouping (one set of 3 cables shall include +, - and neutral)
- Include all the necessary checks and recommissioning tests

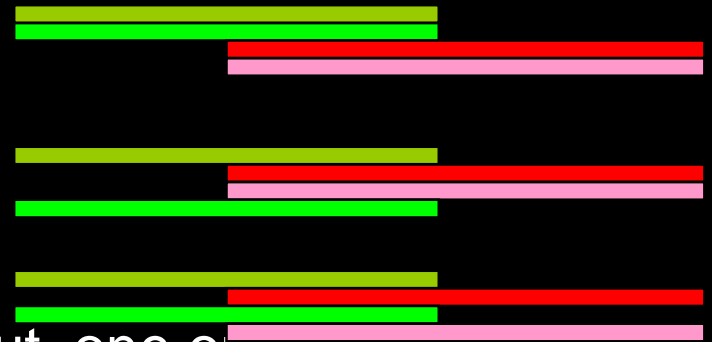
- 12 connections were made
  - ◆ 3 of them insulated
  - ◆ 4 of each type

- De-brazing trials were carried out, one on the mock-up
