Status of Sector 3-4 Repair

Francesco Bertinelli - TE/MSC
(15 minutes)

A very general overview since Chamonix (3 February, W06):

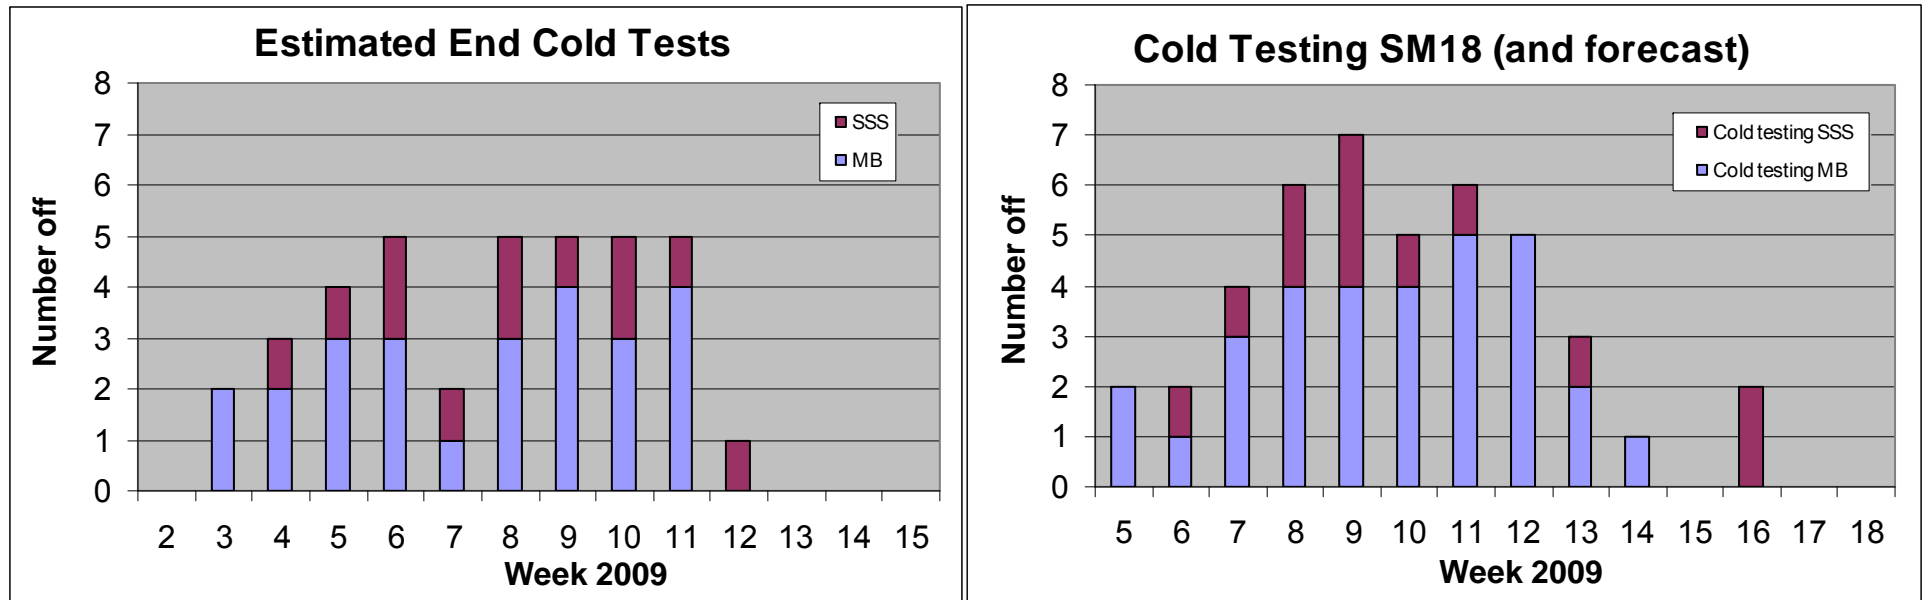
Cold testing SM18

- Increased capacity 18 kW plant W07 and operating teams;
- Improvements in splice resistance measurements, including “4th splice”;
- some delay from cryostating;
- some delay from NCR: MB2420 (29 nΩ splice resistance), MB2868 (electrical), MB2690 MB2427 MB3383 (retesting for splice resistance), SSS344 (replaces SSS006), SSS364 (replaces SSS192).

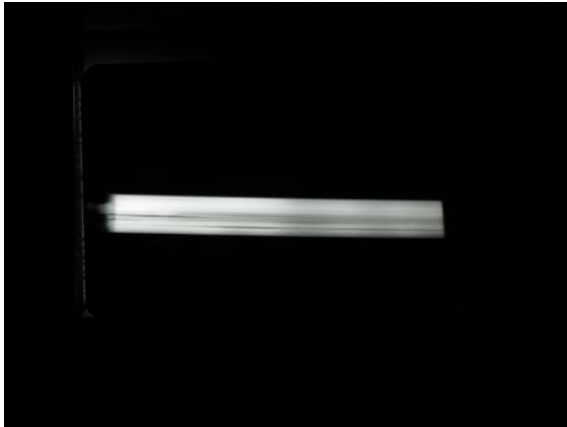
- MB2420 - 29 n Ω : opened, inter-aperture splice poor bonding

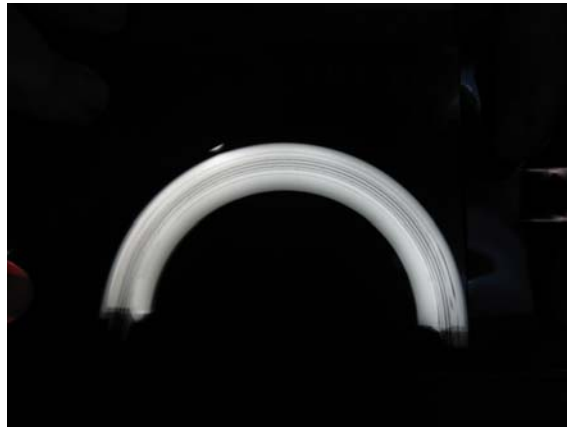
- MB2334 (B16R1 from 1-2) 100 n Ω : opened, inter-pole splice poor bonding

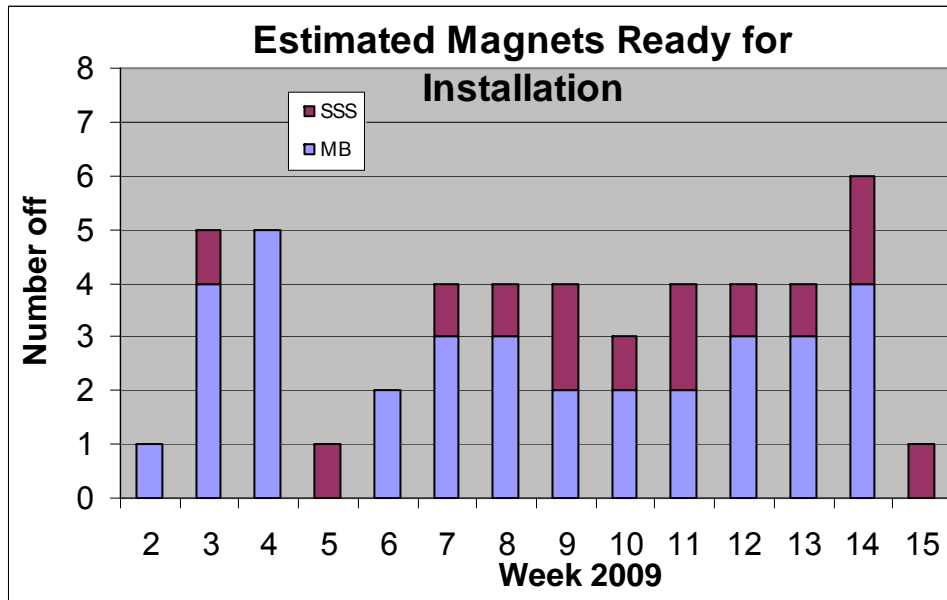
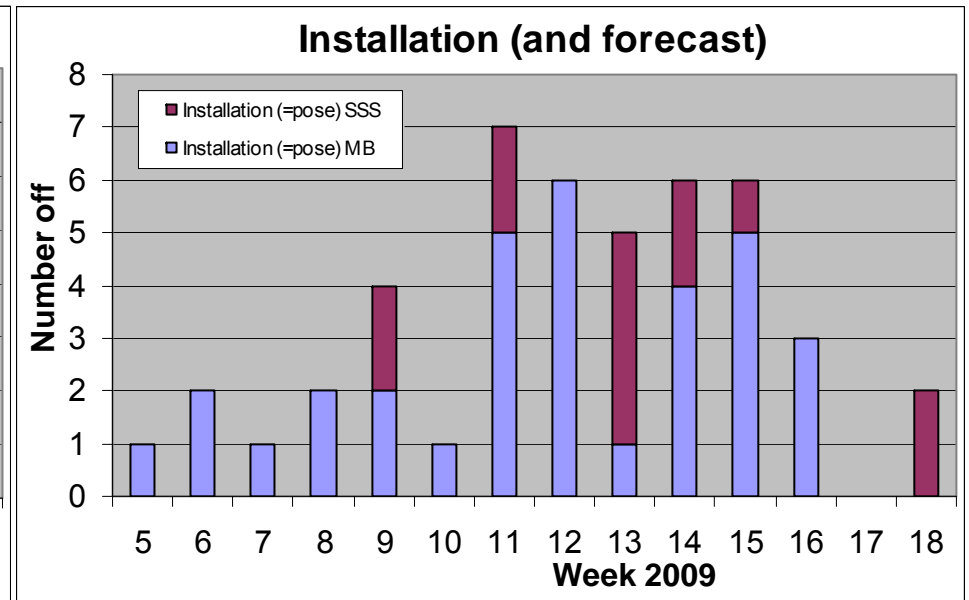
Transport and installation

- MB from Point 3, SSS from Point 4;
- MB finished W16, OK for cooling down 2-3;
- Last 2 SSS in W18;
- Night shift and Saturday work since W10 (to avoid coactivity).

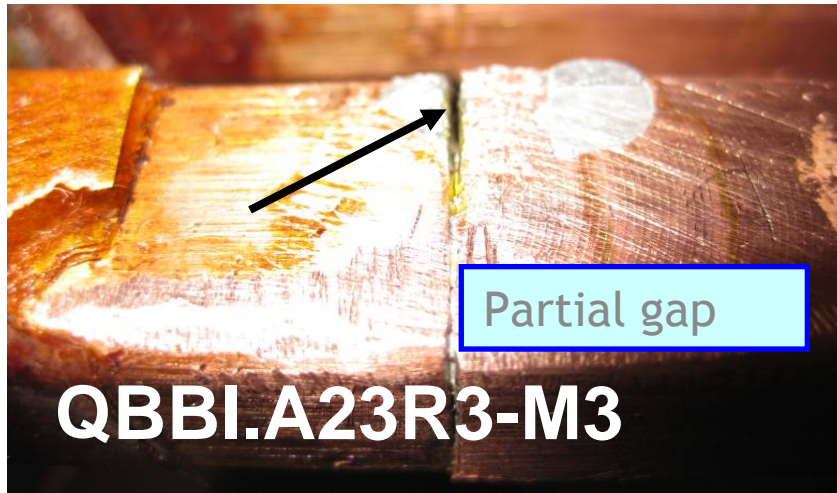
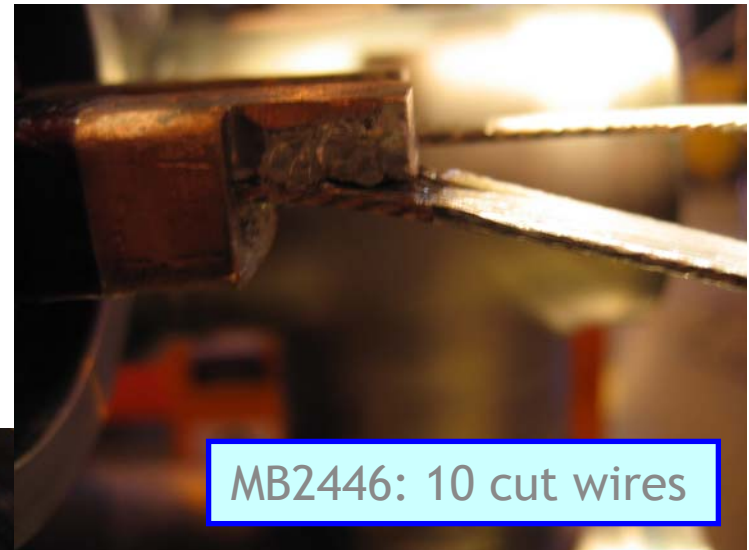
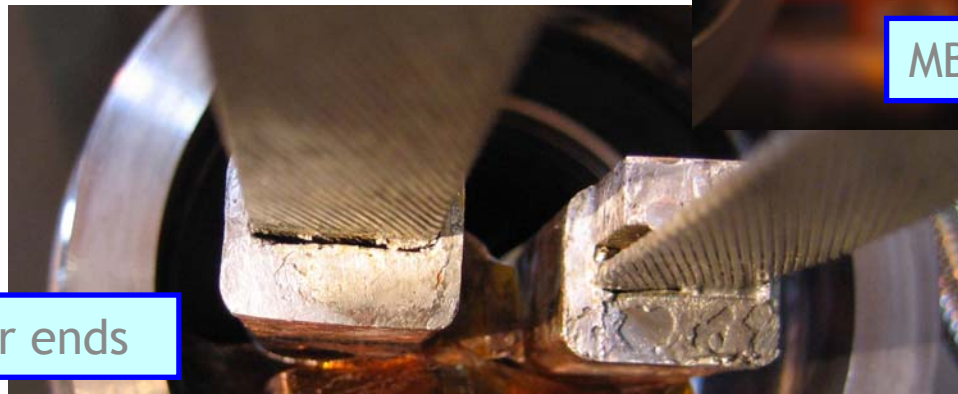
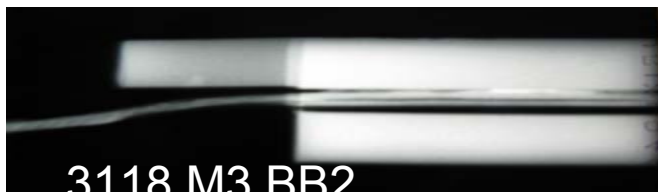
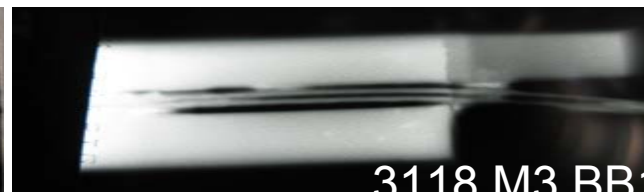
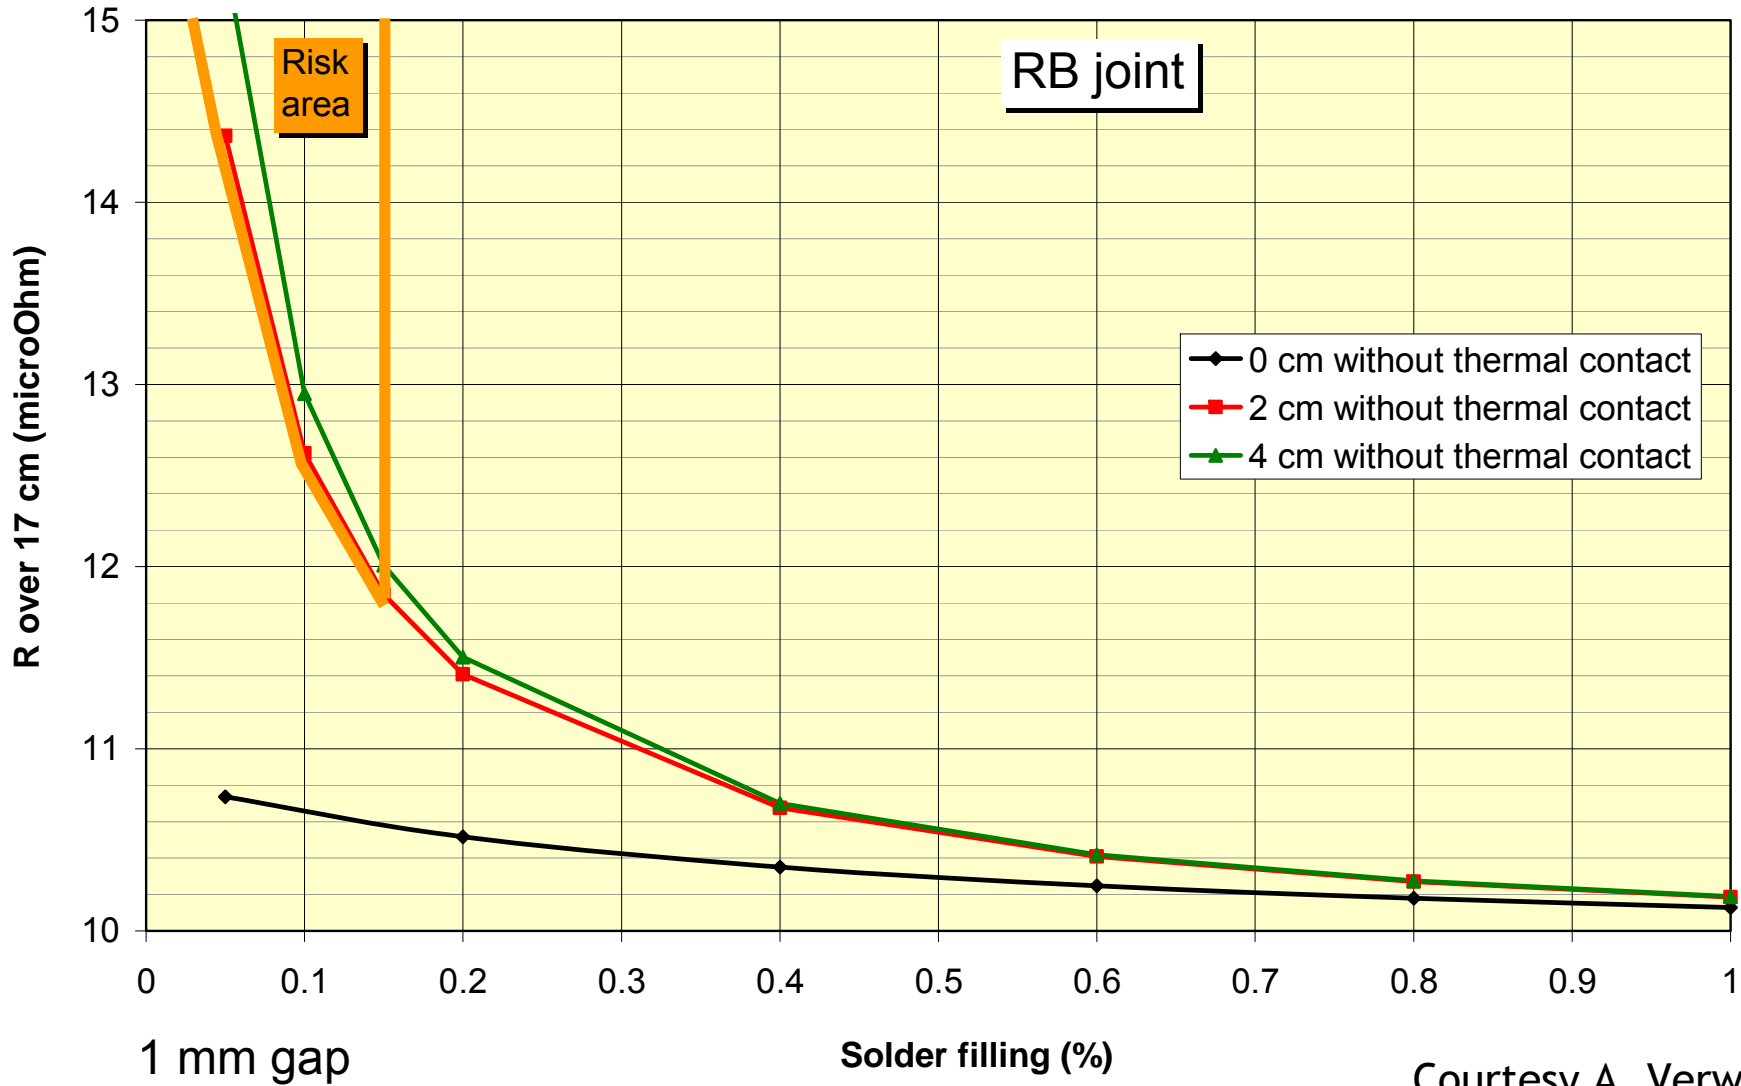
Technical difficulties

Gap + missing Sn

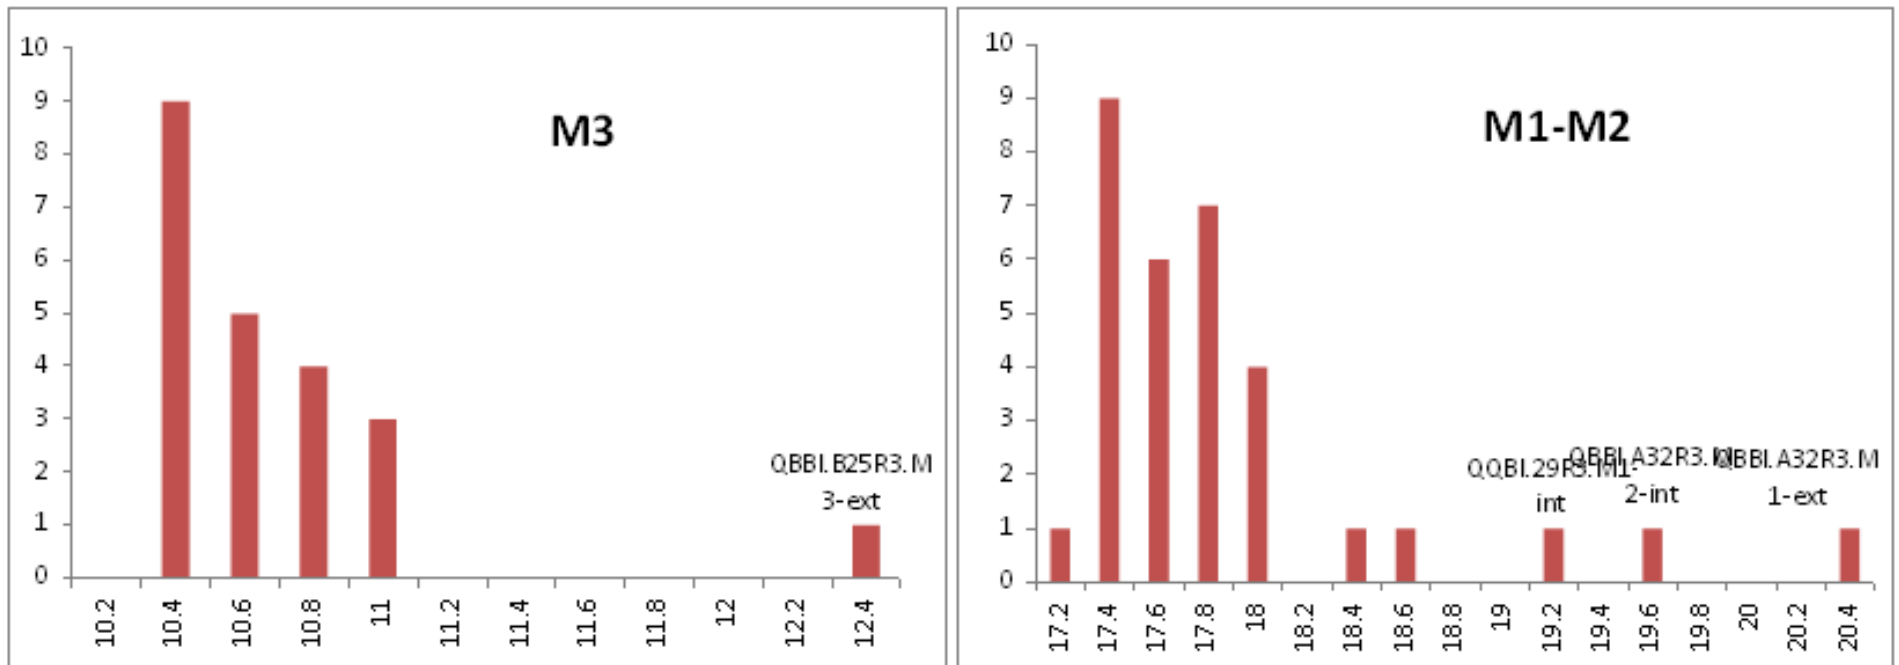
Splice Megger measurements

- Gap splices OK, outliers in cases without visible gap
 - Splice NCRs blocking work (PAQ and M welding): urgent to resolve this (already 1 week delay)
 - Gammas done OK; resistance measurements in 5-6 and 6-7 ongoing
 - Proposal (to be discussed): resolder if $\text{gap} \geq 50\%$ AND resistance $\geq \dots\%$, otherwise record but use as is
- Courtesy C. Scheuerlein, N. Catalan, G. D'Angelo, R. Mompoti

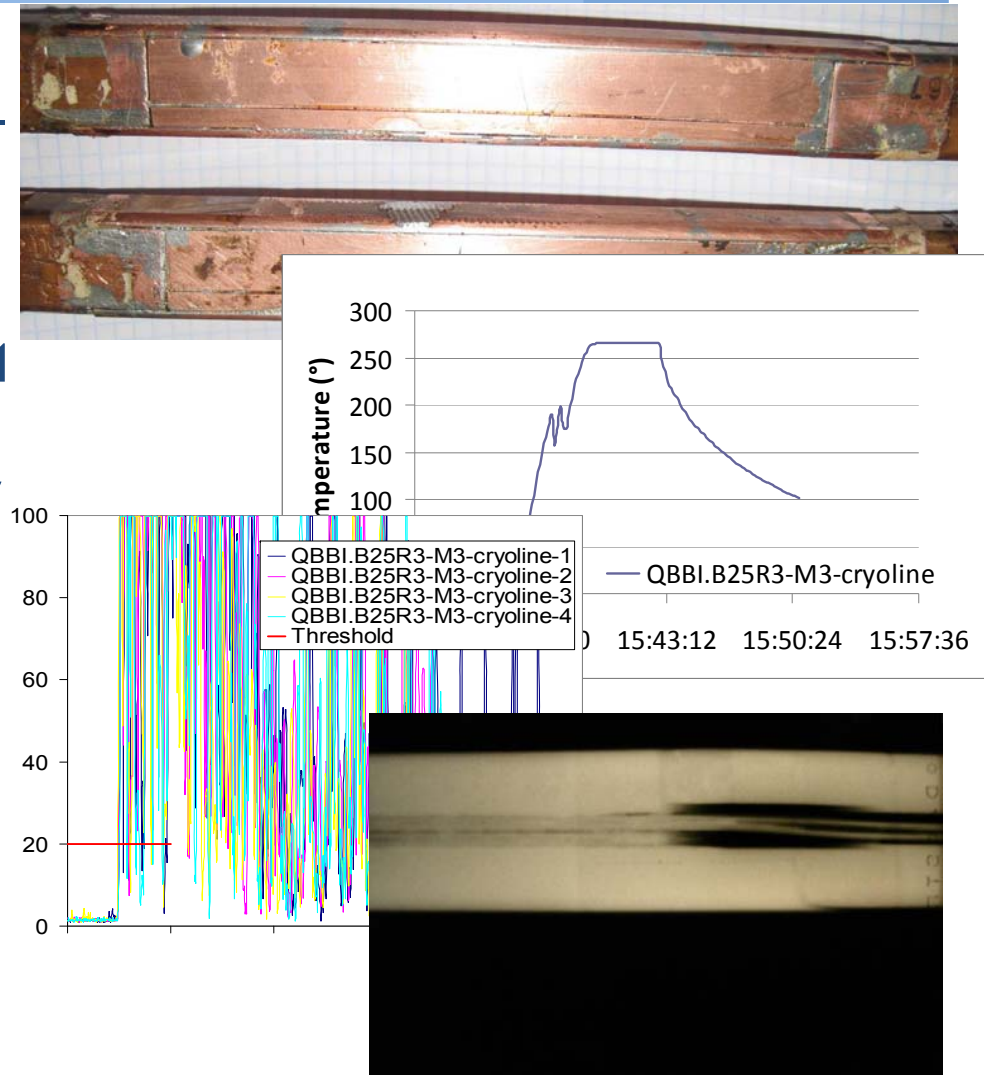
Example QC of QBBI.B25R3

- Produced the 17.3.2009. Special U-piece (-1 mm length) used for M3-corridor side. OK
- Visual and geometric inspection by QC team according to IEG-C-BR-001 rev C, the 18.3.2009. OK
- US-test 4 out of 4 US signals OK for all splices.
- Splice thickness OK.
- NCR 993939 was opened and gamma ray examination was requested for QBBI.B25R3-M3-cryoline, because room temperature splice resistance of $12.4 \mu\Omega$ is higher than average values.

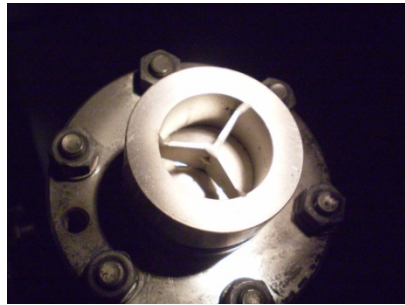
Q8R3 V1: rupture disk deformed but not perforated

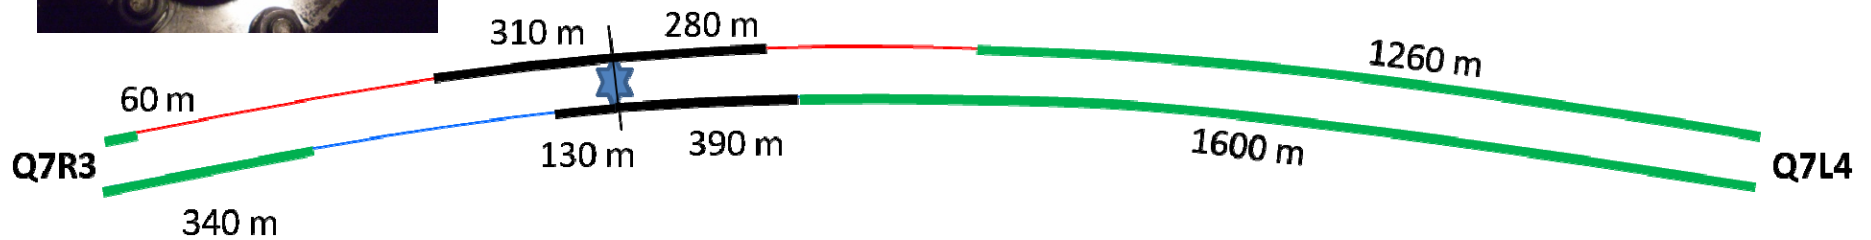
4800 m of beam pipe inspected cm-by-cm and documented with travellers, pictures and videos !

■	Metallic debris
■	MLI
■	OK
■	Soot
■	Oxidized beam screen
■	Mark on surface

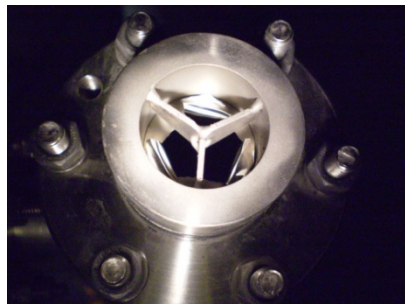
Q8R3 V2: rupture disk blown

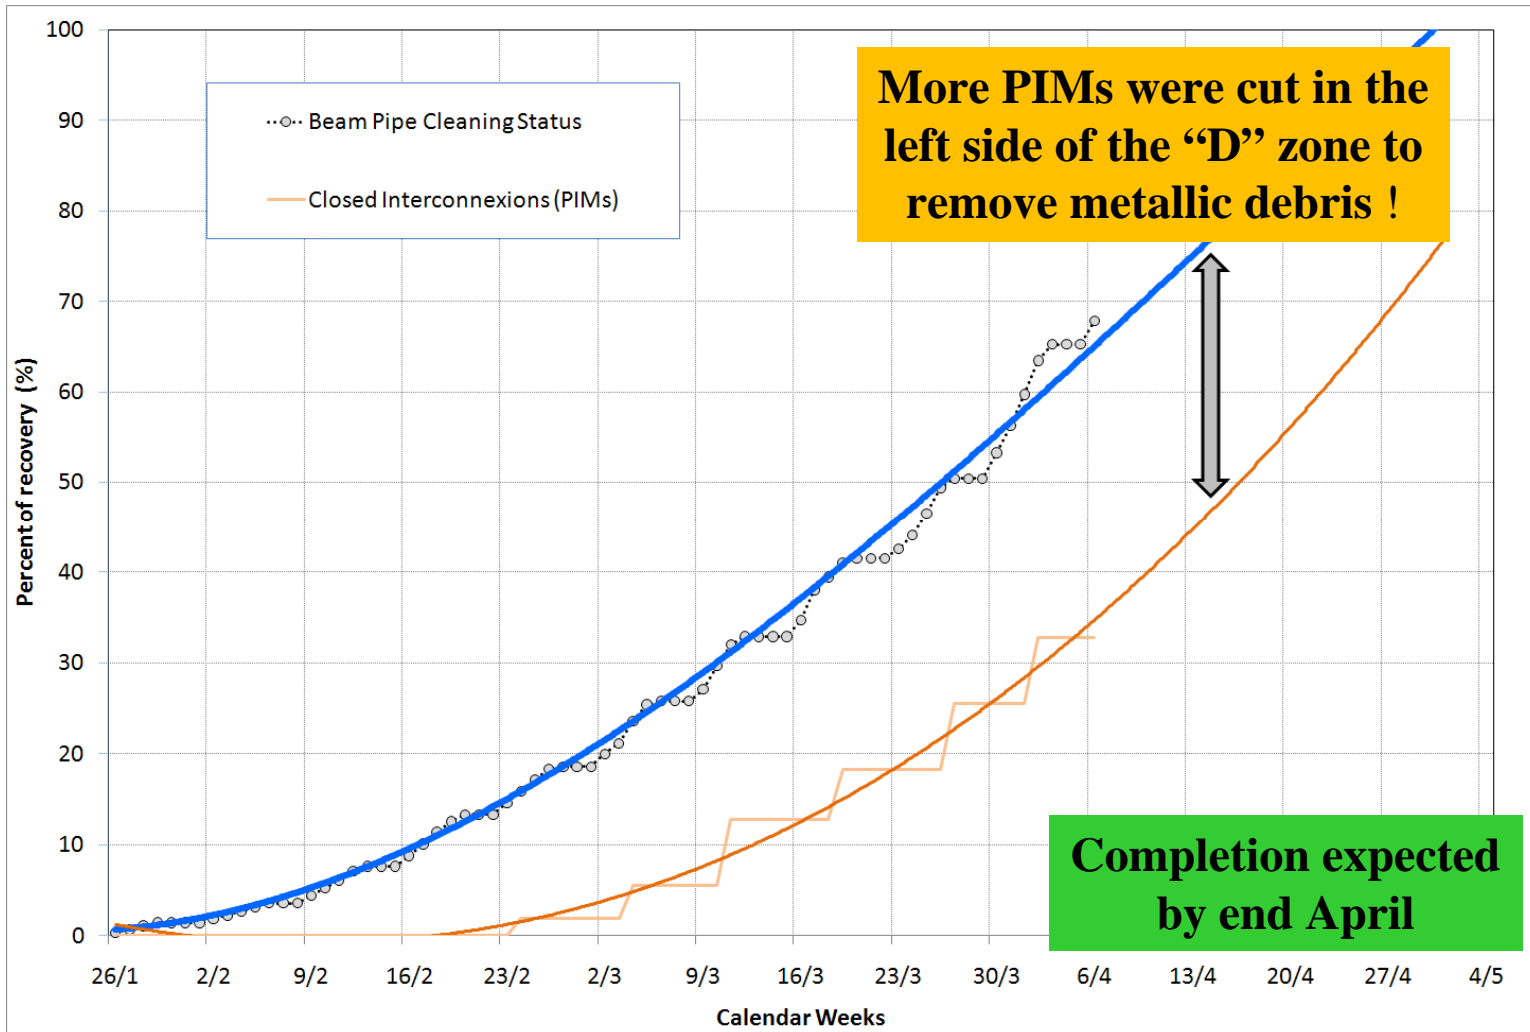
Beam Vacuum Recovery: % of Cleaned Beam Pipes

- Beam Pipe Cleaning: some numbers
 - 4800 m of Beam Vacuum Pipe to be cleaned
 - 10 passages / Beam Line
 - 1 passage for final endoscopic inspection
 - ☞ 52'800 m to be worked out cm-by-cm !
 - Today's Status
 - 68 % of the length is cleaned - right to the "D" zone
 - ☞ 35'900 m !
- 110 PIMs cut to allow for cleaning
 - 59 left to the "D" zone (in 3R side)
 - 51 right to the "D" zone (in 4L side)
 - ☞ 33 % only are re-welded
 - ☞ More PIMs were cut in the left side of the "D" zone to remove metallic debris
