MMM and TEMB - 25 May, 2009

Status Report of Magnet Work Week 21 / 2009

Francesco Bertinelli - TE/MSC

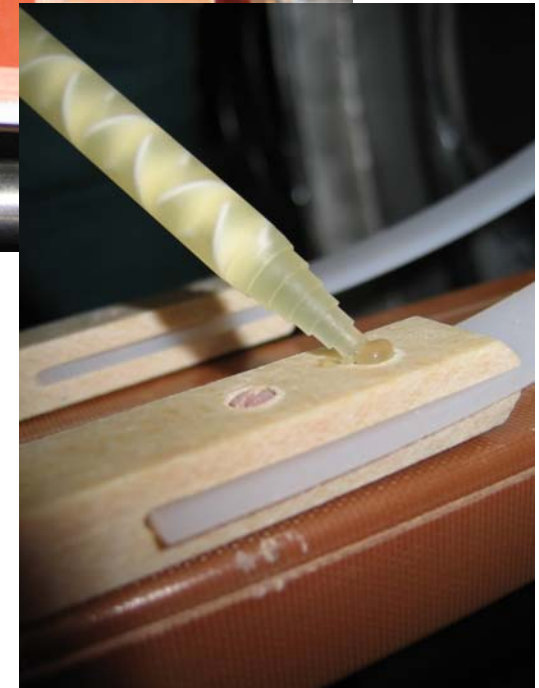
Connection Cryostats

- Good progress
- Insulation fixed points successfully mounted
- 5-6: ready to perform ELQA before starting rewelding (a further 10 days to W closing)
- but will need to reperform ELQA after R16 interventions

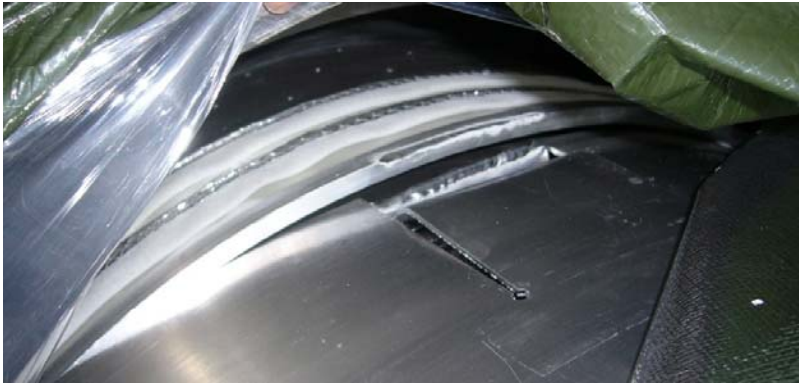
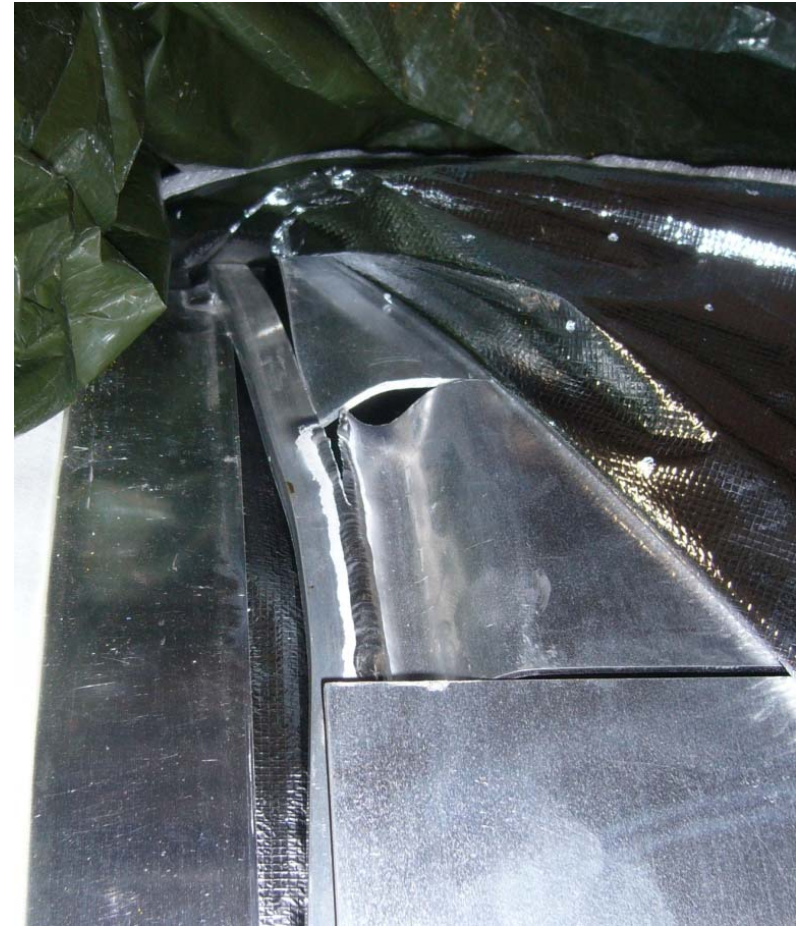
80K radiation/thermal screens

- Damage occurred at both cool-down and warm-up
 - Improve assembly procedure of screens
 - Improve uniformity of temperature during cool-down operation, impact +1 day
