Cryomagnets Interconnections

❖ Consolidation of sector 4-5

Consolidation of sector 4-5

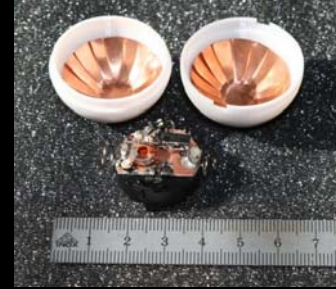
All collapsed PIMs have been localised thanks to the Spoutnik test

- 12 collapsed PIMs in 9 ICs (3 ICs with both PIMs with deformed fingers)
- 10 ICs have been opened for this purpose
- Only QQBI (SSS-DIP) types are affected

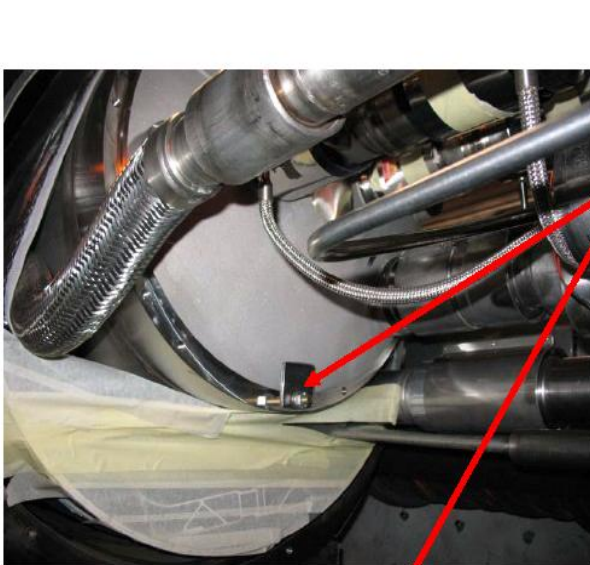
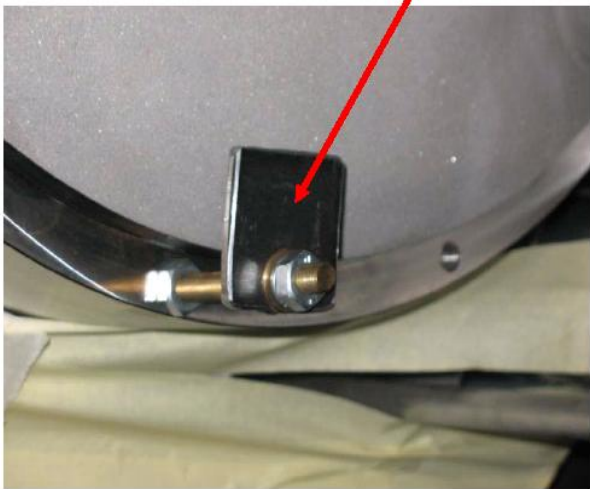
Half yoke samples, fixed with stainless steel threaded rod (M10x100mm), 3 washers and 3 nuts.
