# Cryomagnets Interconnections

# (Inter)Connection Cryostats Status

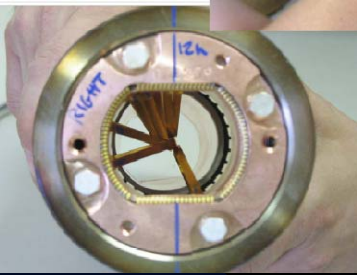
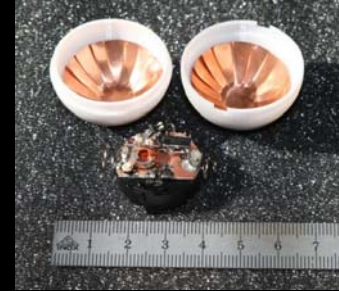
## PIMs replacement

Ball test to localise failed PIMs (2 per beam line) to an accuracy of one half cell [4 per day]

Cutting of the PIM on both lines – Endoscopic inspection (+/- 100m)

Installation of a replacement or dummy PIM - In parallel radar type measurement

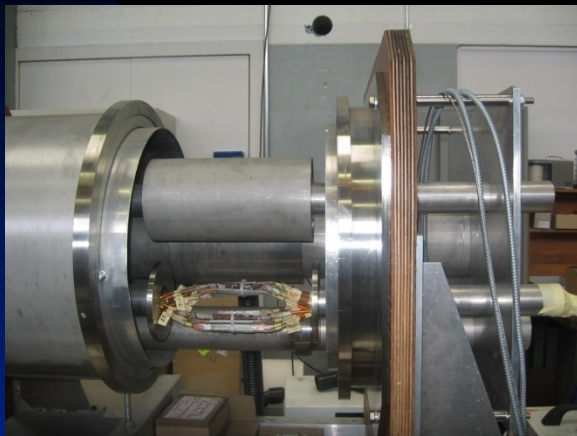
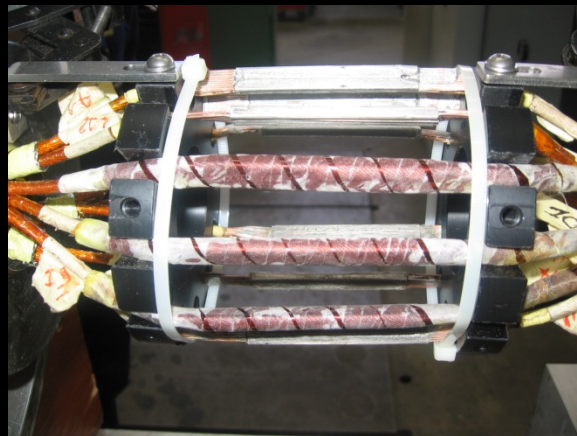
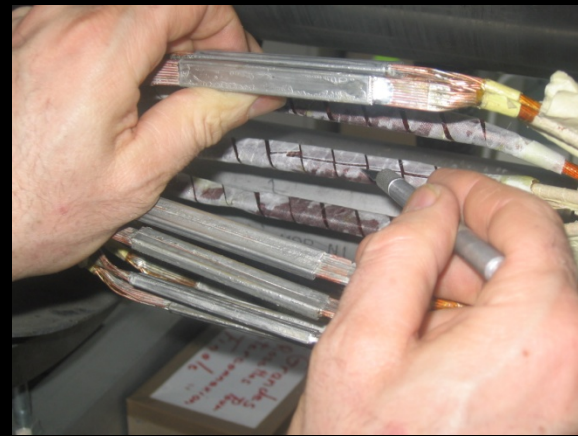
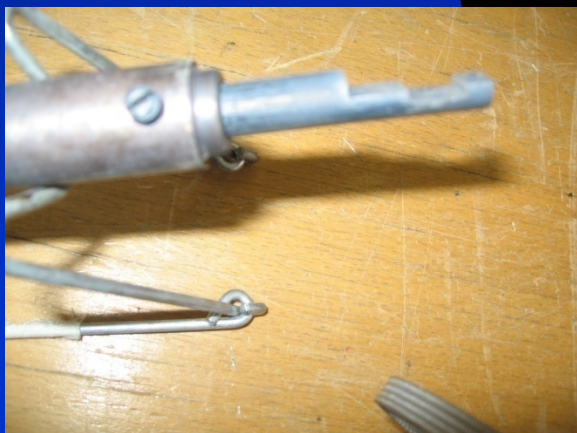
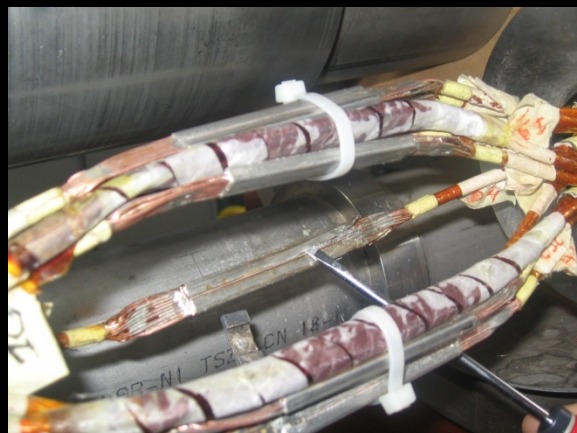
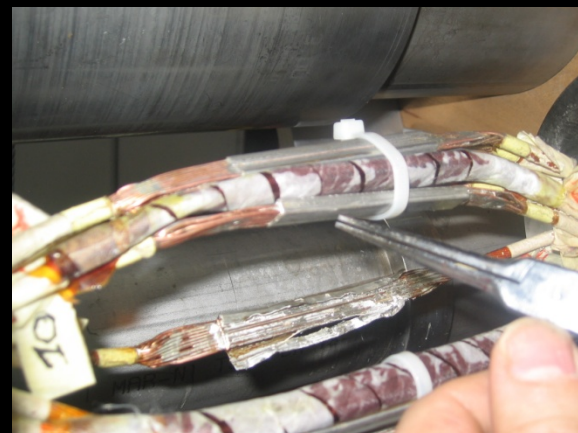
# Mock-up and method

- Launched at the beginning of last week
- To verify the technical feasibility
- To estimate the amount of work and time needed
- To provide hints to help decision
- To anticipate the necessary tooling and replacement pieces

- De-braze other 4 connections
- Re-braze the 5 connections and relocate them in the central region of the assembly
- ... with a mechanical support made out of insulation material
- Hopefully, ready by next Tuesday 18/3 evening
